## TOGA CENTRAL

PEDESTRIAN WIND STUDY

RWDI # 1902973

November 27, 2020

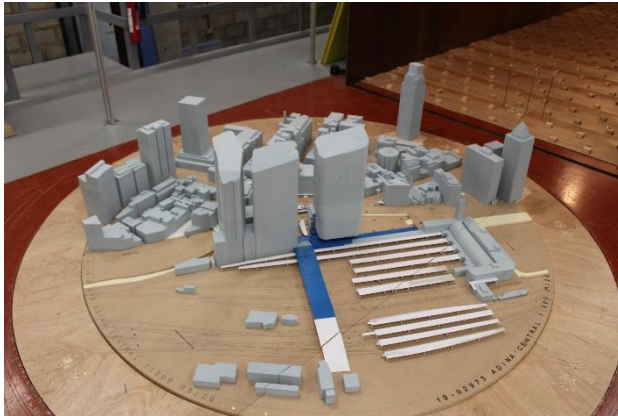
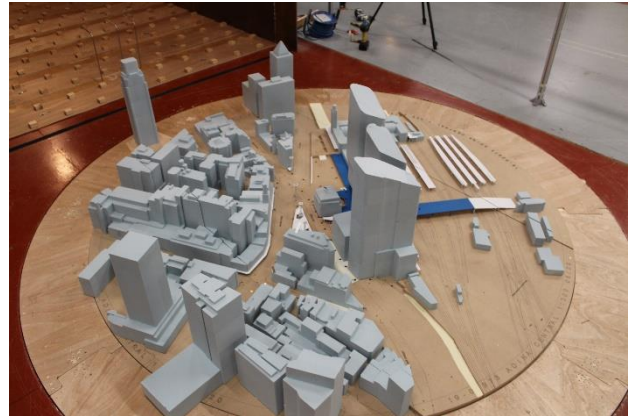
| A - Existing: | Existing site with existing surroundings, including the Block A Winning Design Competition Massing and Block B Public Exhibition Reference Design Massing of the Central Station Western Gateway Sub-Precinct (Image 2A), and, |

Image 2A: Wind Tunnel Study Model - Existing Configuration

To assess the wind environment around the proposed development, a 1:300 scale model of the development site and surroundings was constructed for the wind tunnel testing of the following configurations:

The wind tunnel model included all relevant surrounding buildings and topography within an approximately 360 m radius of the study site. The wind and turbulence profiles in the atmospheric boundary layer beyond the modelled area were also simulated in RWDI's wind tunnel. The wind tunnel model was instrumented with 80 specially designed wind speed sensors to measure mean and gust speeds at a full-scale height of approximately 1.5 m above local grade in the pedestrian accessible areas throughout the study area. Wind speeds were measured for 36 directions at 10-degree increments. The measurements at each sensor location were recorded in the form of ratios of local mean and gust speeds to the mean wind speed at a reference height above the model. The placement of wind measurement locations was based on our experience and understanding of the pedestrian usage for this site and reviewed by the client.

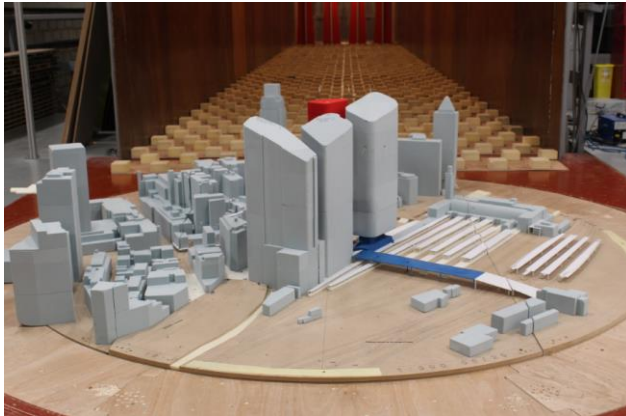
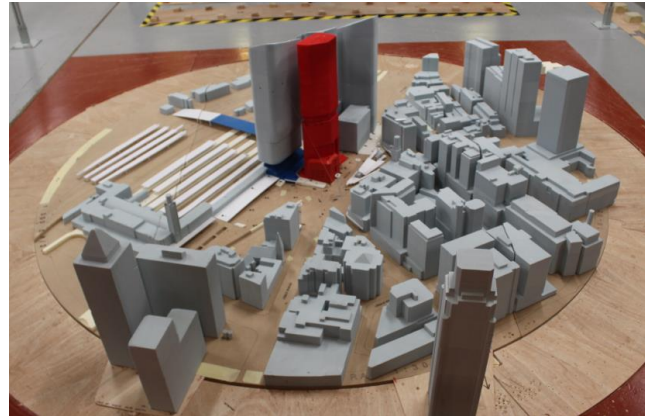
| B - Proposed: | Proposed development with existing surroundings, including the Block A Winning Design Competition Massing and Block B Public Exhibition Reference Design Massing of the Central Station Western Gateway Sub-Precinct - (Image 2B). |

Image 2B: Wind Tunnel Study Model - Proposed Configuration

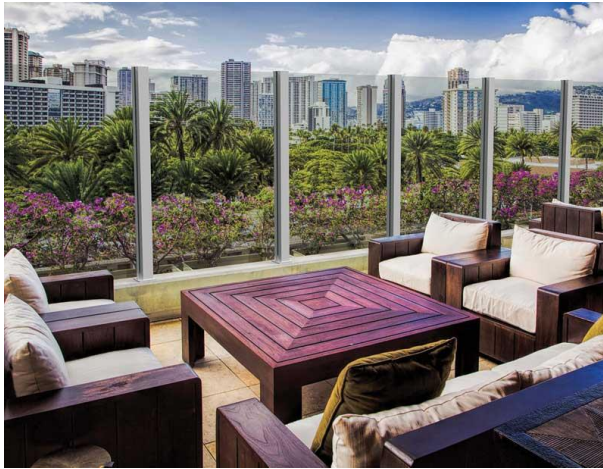
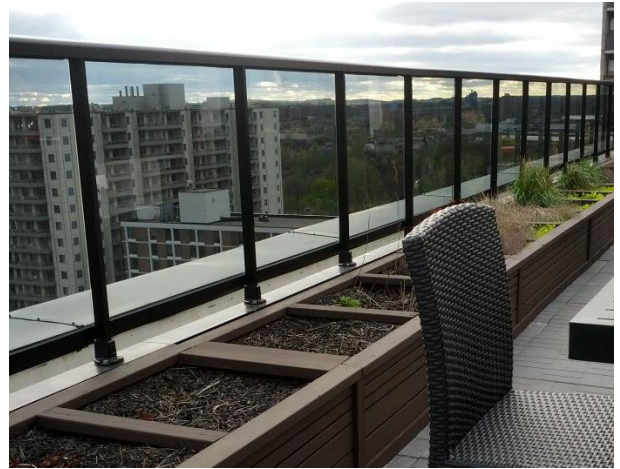
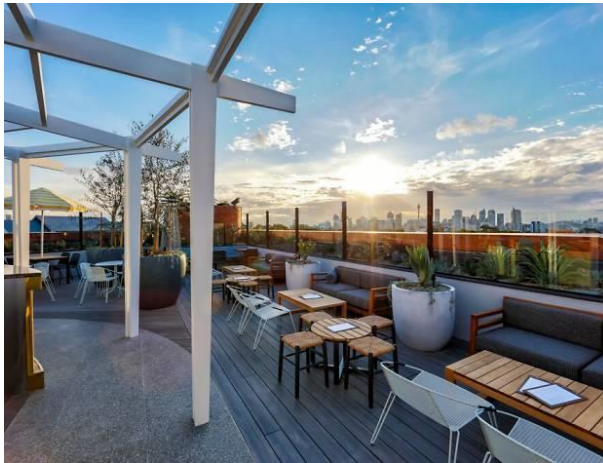
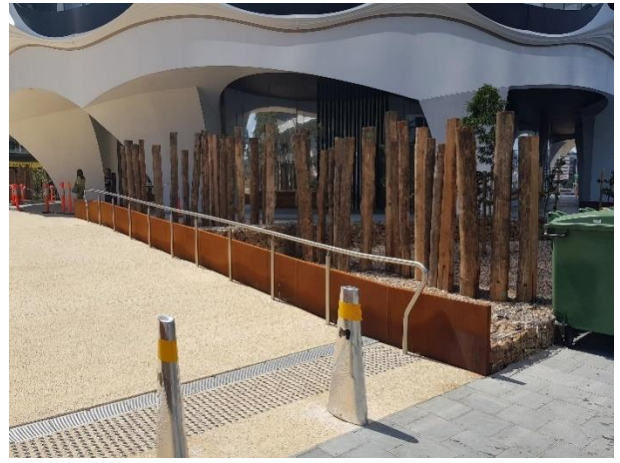
Image 5: Examples of Landscaping and Screening Elements for Terrace Spaces

There is a setback around the perimeter of Level 20. This area has been modelled as recessed terrace as part of the reference massing, with no consideration for required balustrade/screening included as part of this study to provide an indication of wind conditions in the area. All areas are subsequently expected to experience conditions which exceed the safety limit criteria and generally encounter uncomfortable conditions for people using this space. Any elevated terrace space will need to consider these wind conditions as the design develops to ensure that suitable conditions can be provided for use by patrons. Elements to consider may include porous or solid screening as well as localized landscaping to help reduce these conditions. Alternatively, the consideration for compartmentalization of outdoor terrace spaces to minimise the potential for funneling through voids. It is also noted that this feature is expected to have provided some benefit to reducing the downwash to lower level areas so should not be completely closed off.
