Appendix F Riparian Corridor Management Plan

Mamre Road Precinct Rezoning: Waterway Assessment

Kemps Creek and Mount Vernon

Prepared for: Sydney Water

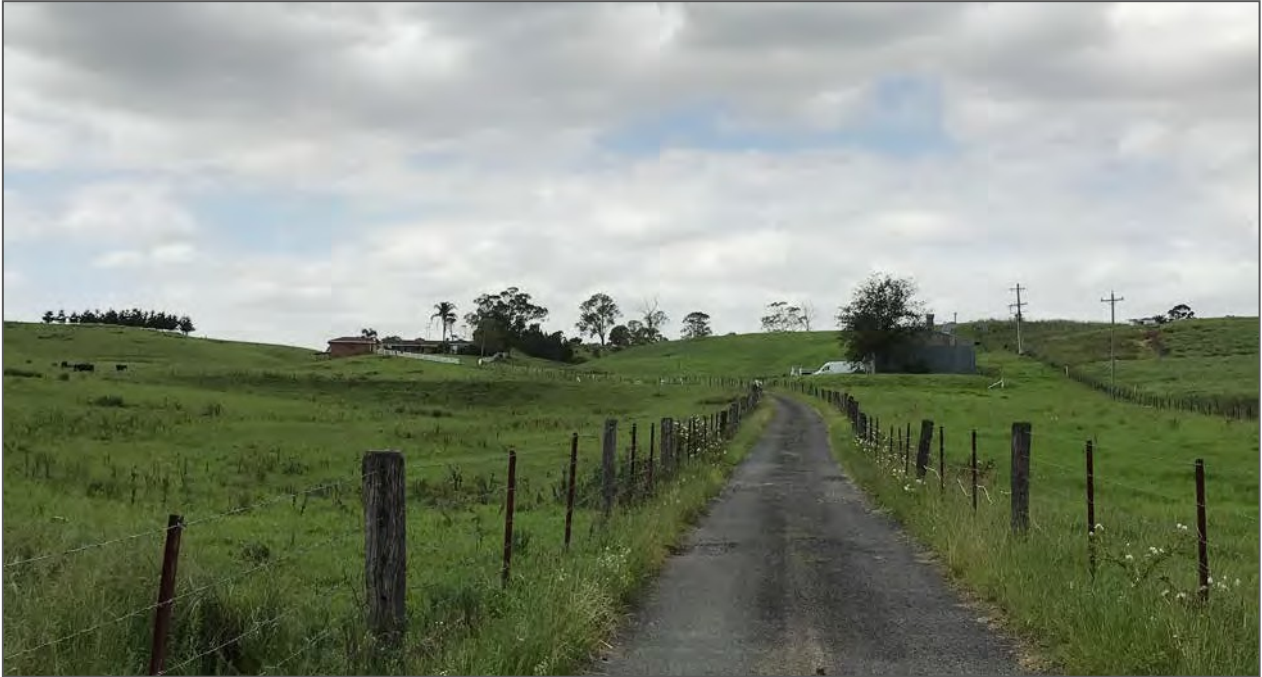
Figure 3: Upper headwater 1st order waterways on Unnamed Trib Kems Creek 1.

Results of the inspection of Unnamed Trib Kemps Creek 1 validated the waterway is of 2nd order. Two first order watercourses were evident in the headwaters which run to the north and south of the house in the upper catchment (Figure 3). A clear flow path was evident below their confluence which validated the presence of a 2nd order watercourse. The flow path did not have defined bed and banks which is likely due to the buffering of flow velocity and erosion provided by three upstream farm dams (Figure 5).

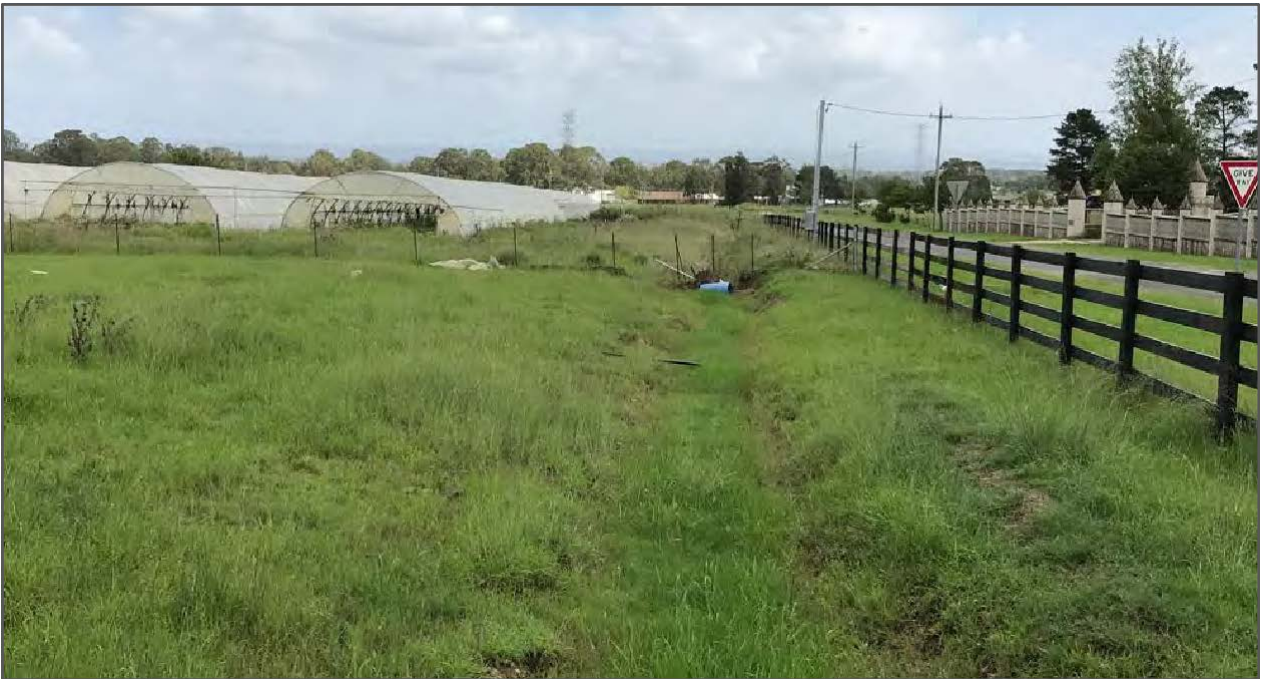
However approximately 200 m below the confluence the waterway was heavily modified and formed into a drainage channel which was realigned to direct flows along a channel which runs parallel to Abbot Road and continues to Mamre Road (Figure 4).

Figure 4: Lower highly modified section of Unnamed Trib of Kems Creek 1.

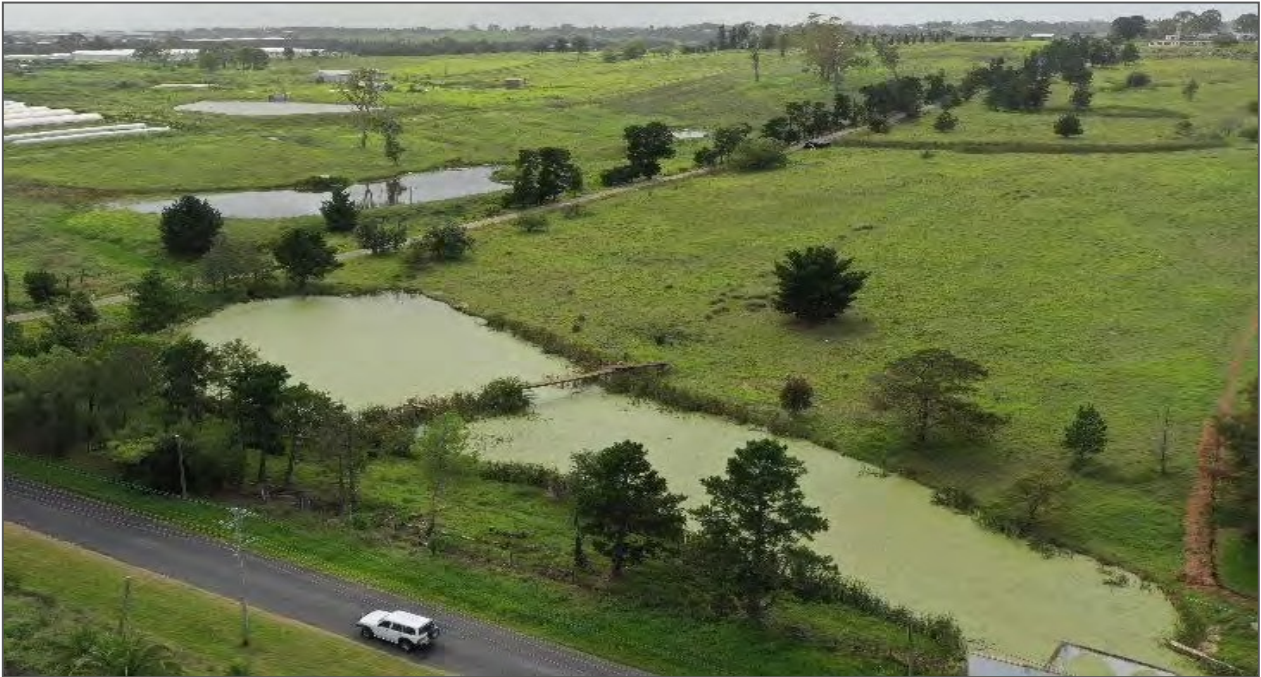
Field inspection of Unnamed Trib Kems Creek 2 validated the waterway is of 2nd order. Two 1st order watercourses were evident in the headwaters which rise to the east of Adlington Road (Figure 6, Figure 7), both of which are significantly modified due to the construction of a series of farm dams along their flow paths (Figure 6, Figure 7). Native riparian vegetation was absent from both watercourses.

Figure 6: Northern 1st order watercourse above confluence point, east of Adlington Road, Unnamed Trib Kems Creek 2.

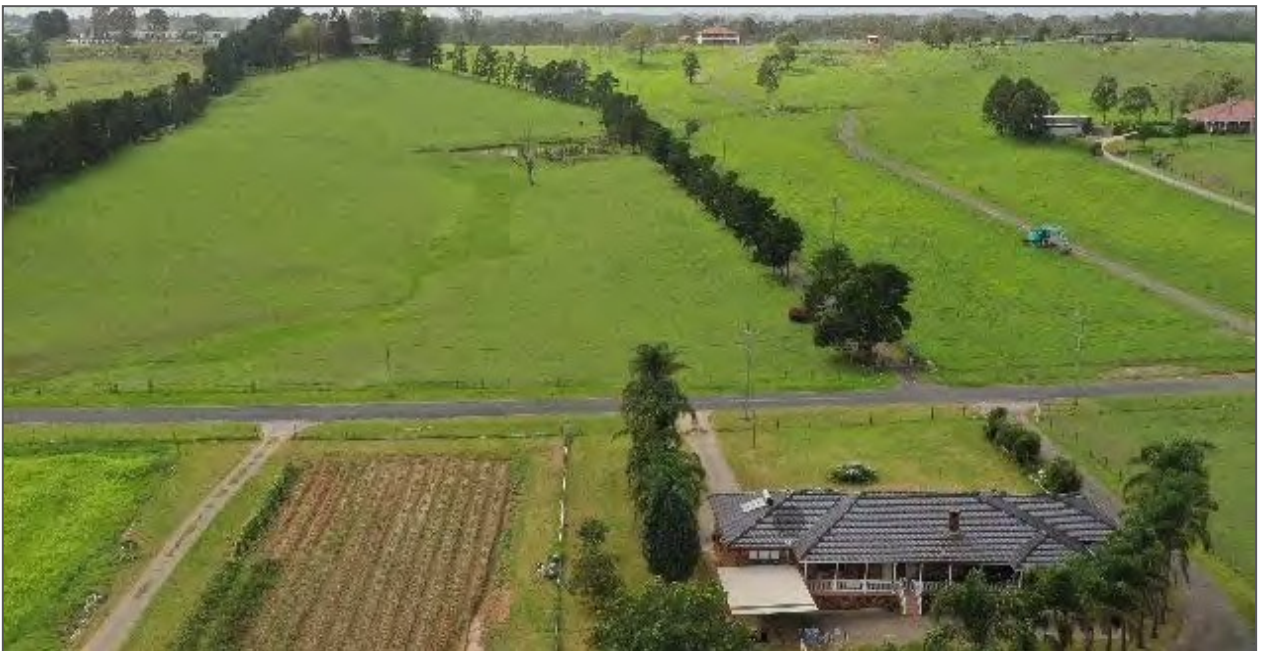
Figure 7: Southern 1st order watercourse above confluence point, east of Adlington Road, Unnamed Trib Kems Creek 2.

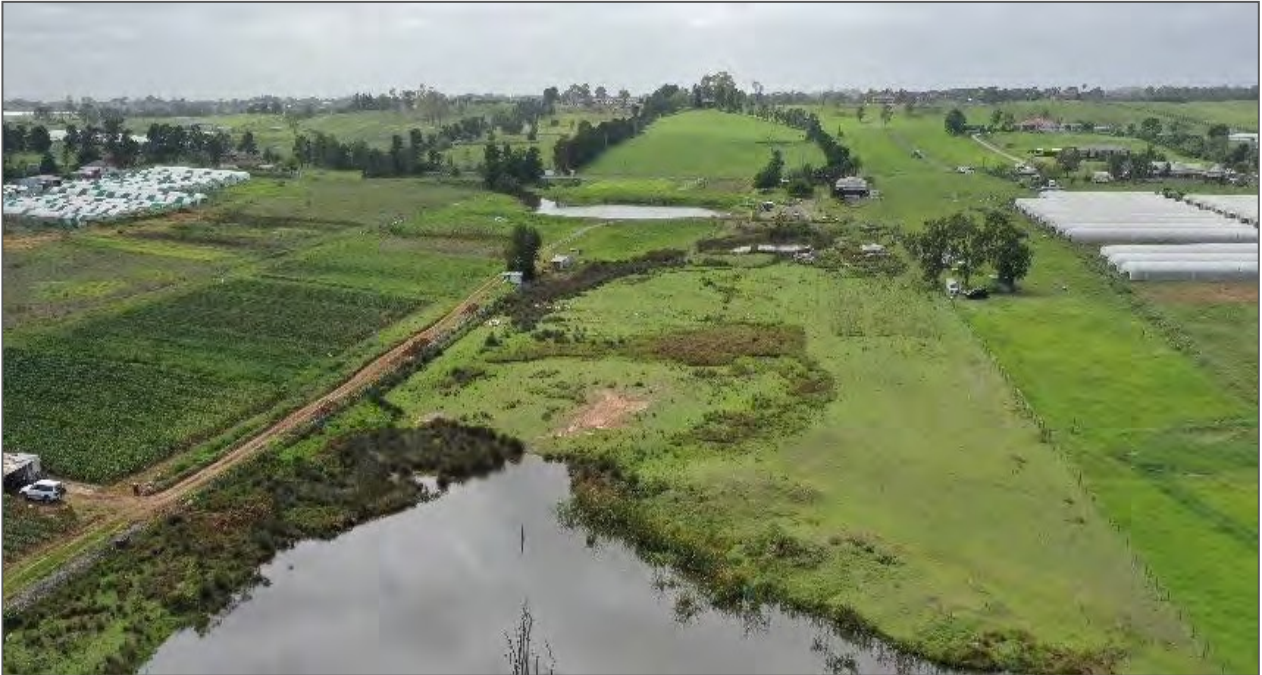
The lower section of this waterway which was proposed for E2 and RE1 zoning in the Exhibited Draft Mamre Road Precinct Zoning (DPIE 2020) in the draft was field validated as 2nd order however this section is significantly modified and at the time of inspection was a series of farm dams linked by a drainage channel and diverted from the original flow path (Figure 10). The channel had a heavy infestation of the invasive weed, *Juncus acutus* (Figure 8).

The original flow path of this waterway, likely to have been a broad, swampy depression which meandered through the centre of the area shown in Figure 8, has been significantly modified to become a market garden and pig paddock and has been deeply furrowed to allow crop irrigation (Figure 9).

Figure 8: View looking towards the east over the proposed E2 and RE1 zoning. Diversion channel can be seen running parallel to the track on the left.

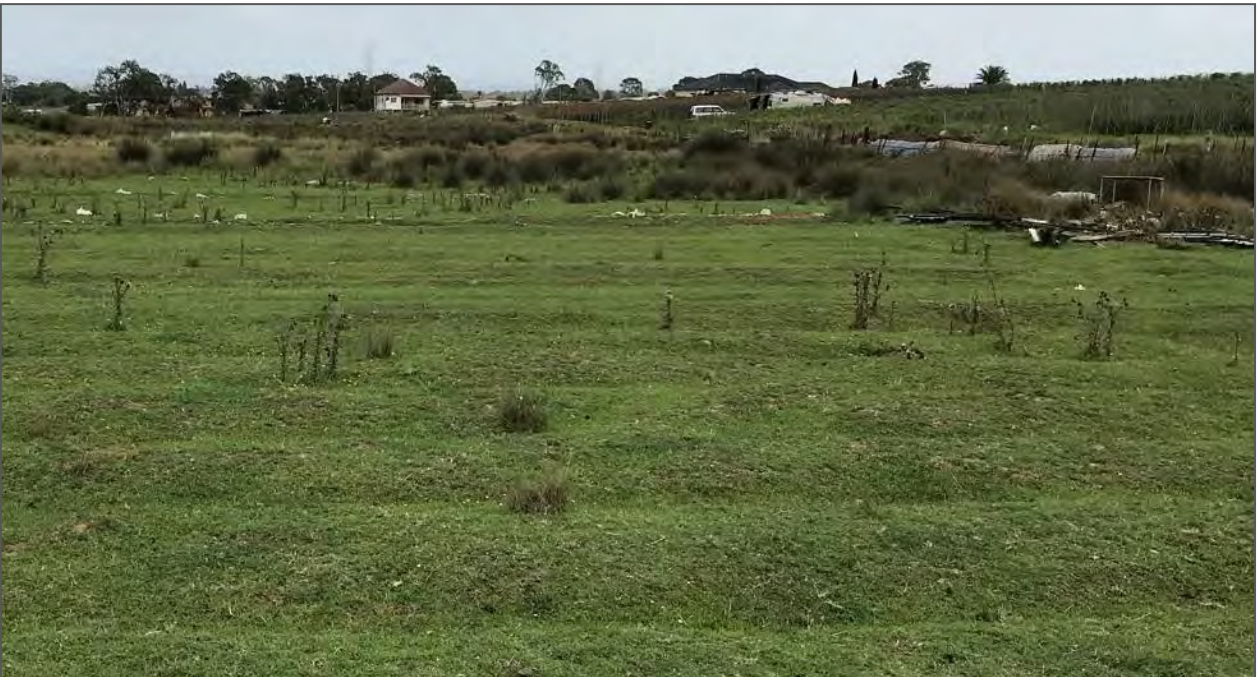
Figure 9: Deeply furrowed section of the adjacent to the drainage diversion channel in the proposed E2 and RE1 zoning area.

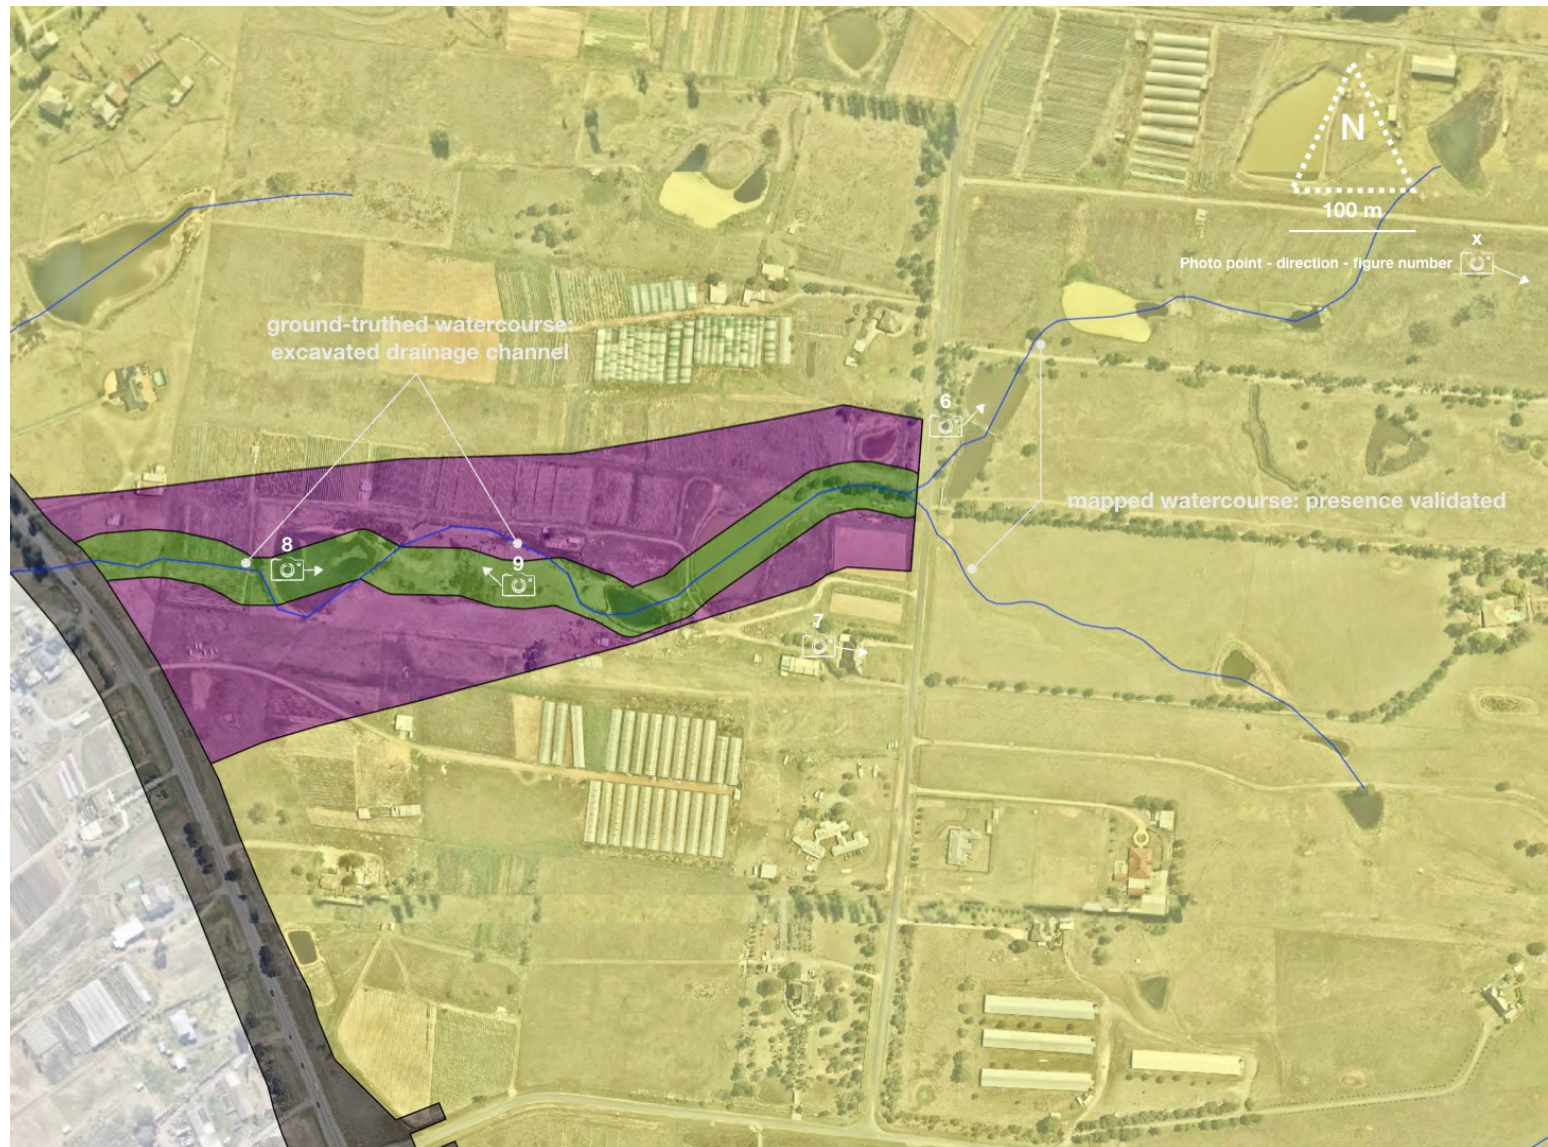
INSET MAP 2

Field inspection of this watercourse validated that the mapped lower section was significantly modified to be a series of farm dams linked by a diversion channel. It was concluded that due to the lack of vegetation along the upper section of the headwater watercourses and significant modification to a drainage channel of the lower section, the watercourse had minimal ecological value.

Figure 10: Unnamed Trib Kemps Creek 2. Field validated channel flow path and validated watercourses.

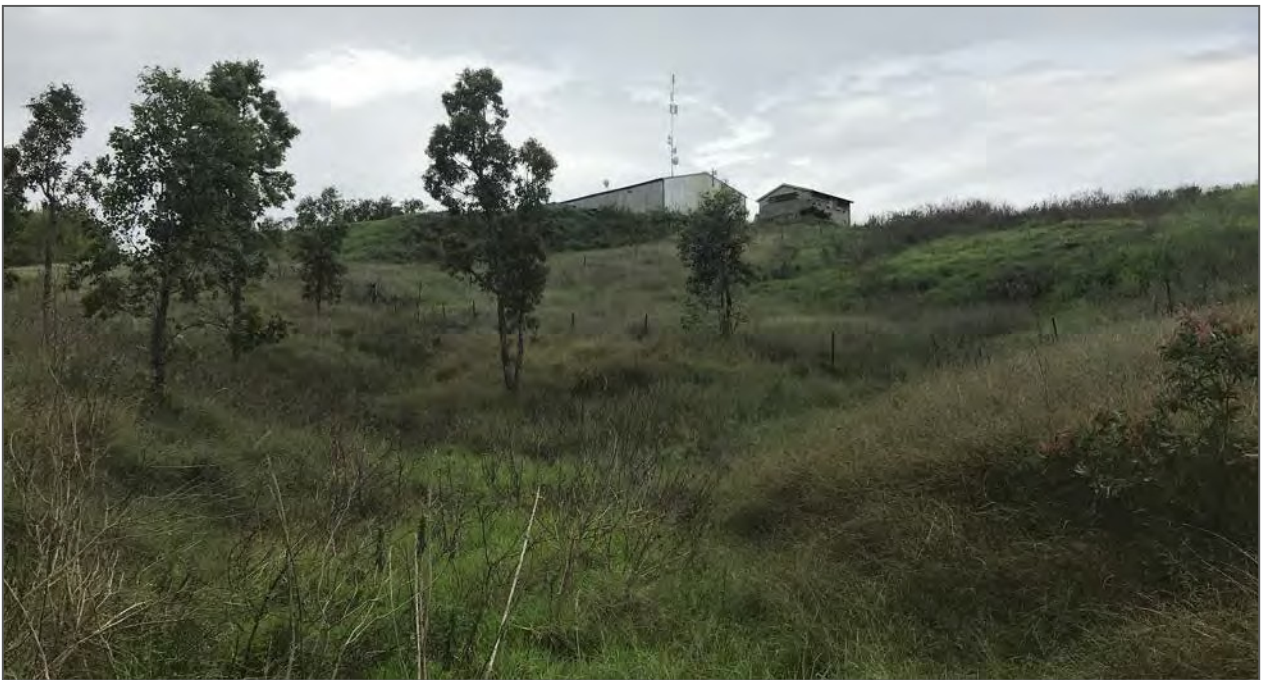
The most eastern extent of the mapped 1st order stream was field validated as not fulfilling the definition of a river as per the *NSW Water Management Act 2000* and therefore was considered as a topographic feature in the landscape (i.e. a depression) rather than a watercourse (Figure 11).

Figure 11: Upper most section of mapped 1st order waterway which is considered by this assessment as not present.

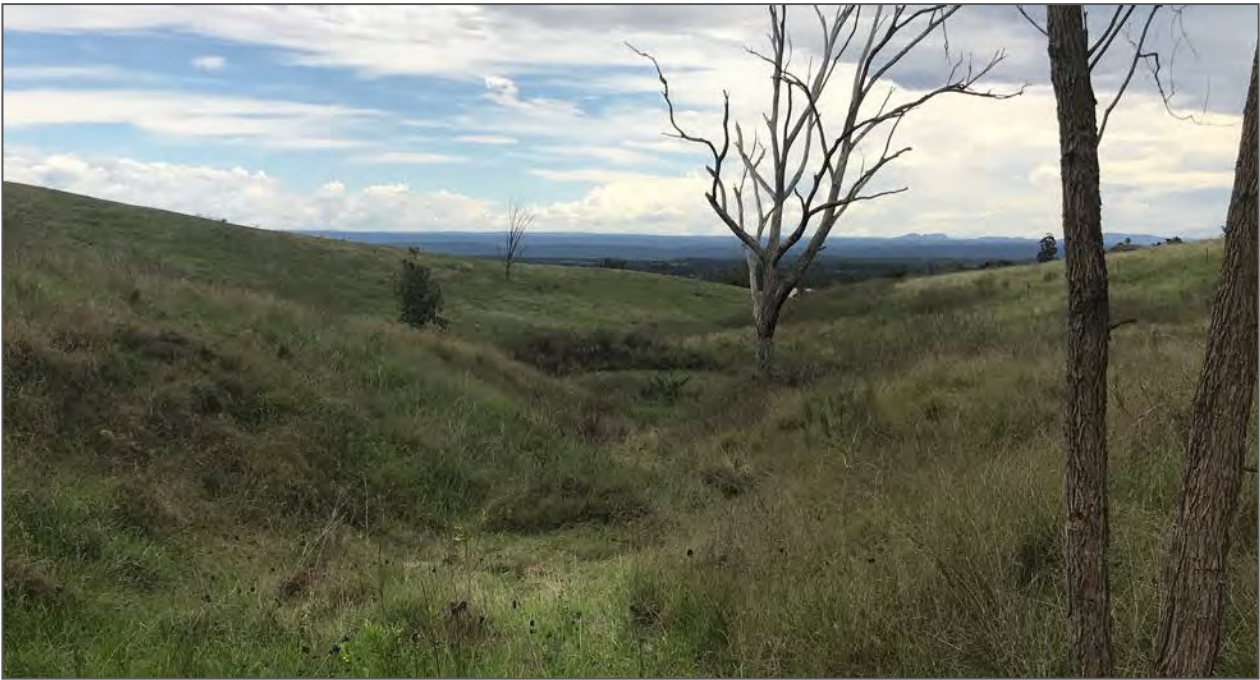
The mapped watercourse section below this point and the most upper mapped 2nd order section had a defined bed and bank which was DGPS mapped (Figure 12). As a result, a 10 m Vegetated Riparian Zone measured from top of bank is required on the 1st order section which will increase to a 20 m Vegetated Riparian Zone for the 2nd order section (as per NSW Water Management Act 2000) (Figure 18)

Figure 12: Mapped upper 2nd order section with bed and bank evident.

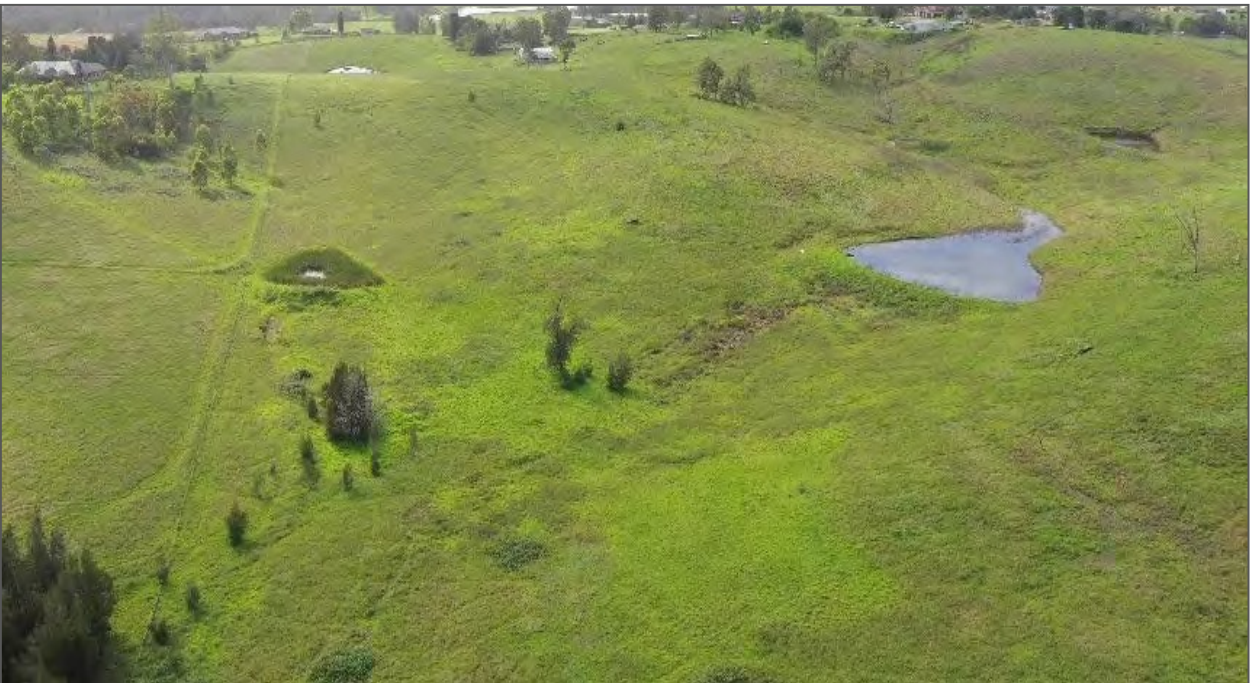
Downstream of the creek section with defined bed and bank the flow path transformed to a broad and shallow depression. No bed and bank was evident for most of this section and it is likely the series of large farm dams within the drainage path has buffered the depression from high velocity flows and erosion (Figure 13).

Figure 13: Typical broad and shallow flow depression in 2nd order section of watercourse.

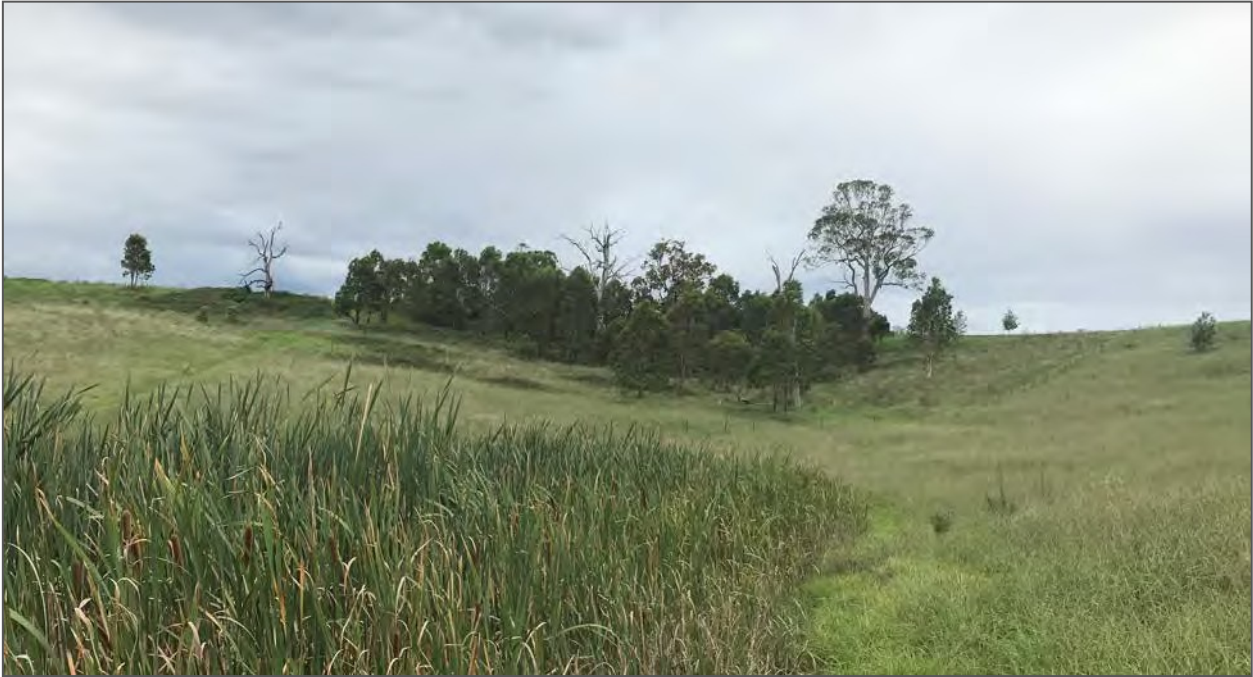
At the time of inspection, a clear flow path was identified although no bed and bank was evident. This watercourse contained a small dam that was full of *Typha orientalis* and linked to a remnant patch of native bushland higher up in the valley headwall (Figure 14).

Figure 14: Field validate unmapped tributary with farm dam in foreground and native vegetation patch in the upper section.

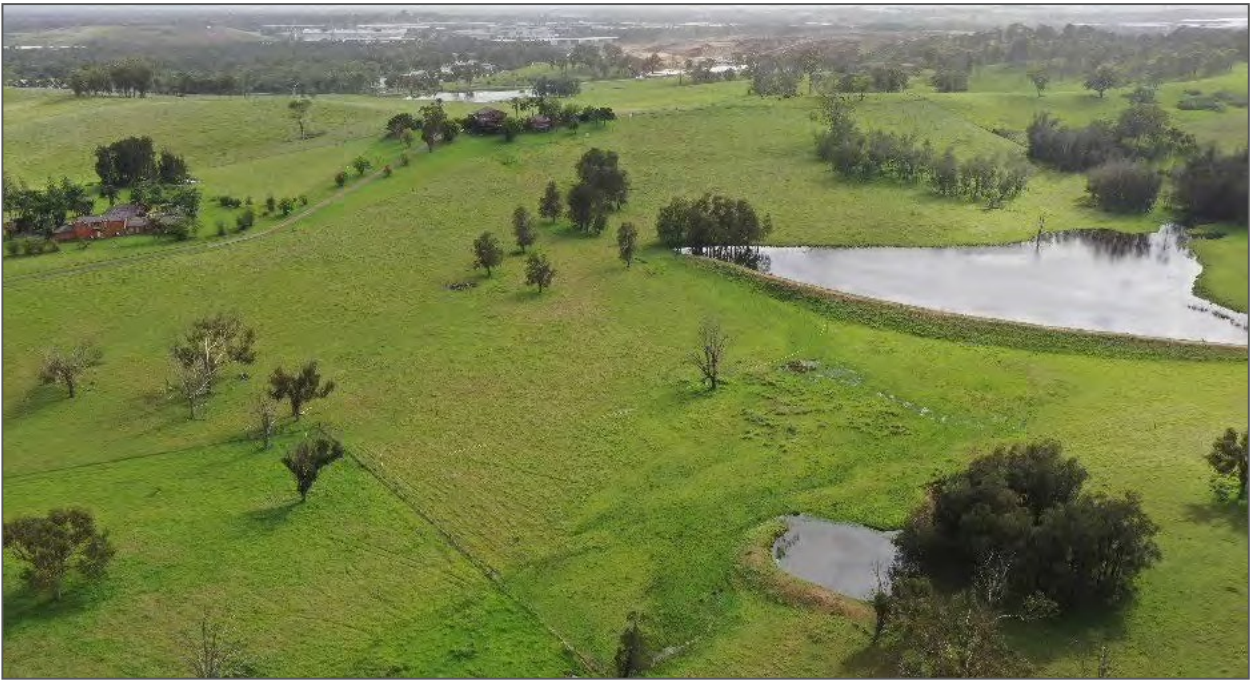
Within the mid-section of this watercourse two large dams are present which have likely buffered this flatter section from high velocity flow and erosion. As a result, no bed and bank was evident however a broad and shallow drainage depression that contains overland flows when rainfall is sufficient to trigger dam overflow was apparent (Figure 15).

These large dams were found to contain a range of aquatic and riparian habitats which included fringing wetland vegetation, shallow marsh and standing dead trees. The dam pictured in Figure 15 has a dense stand of *Casuarina glauca* at the upstream end (top right corner) which provides habitat value.

Figure 15: Mid-section of watercourse with large farm dam. Overland flow path is evident on downstream side of dam.

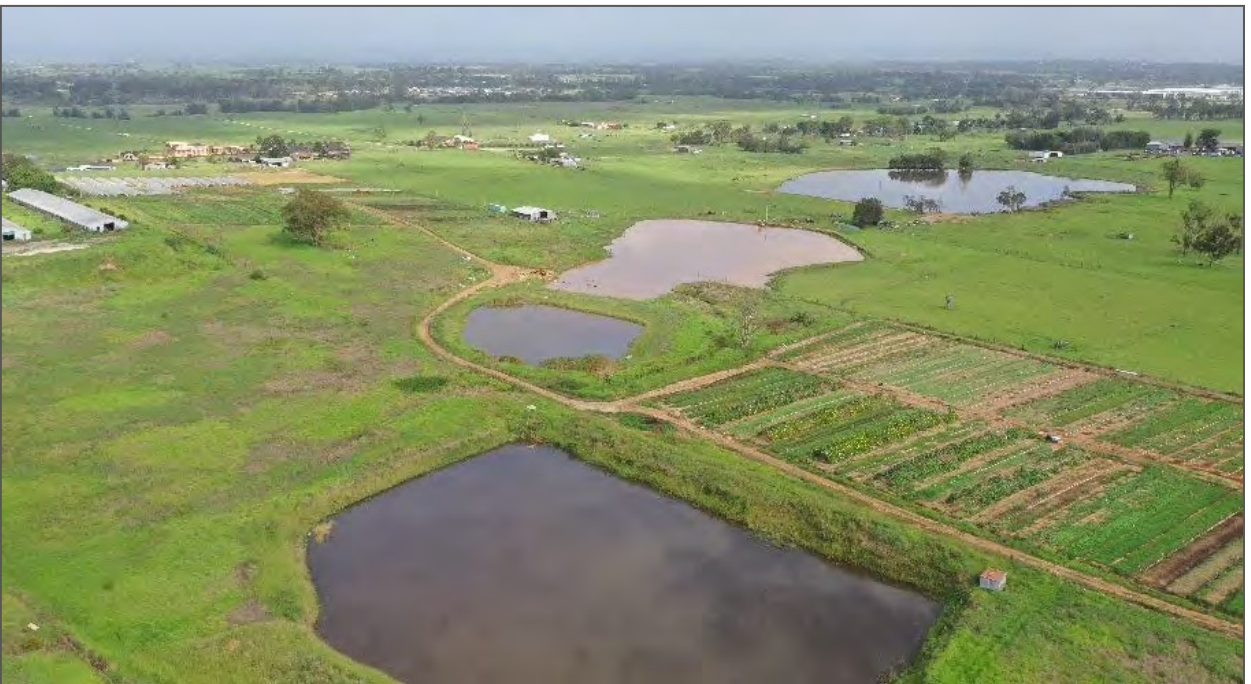
Field validation of the unnamed 1st order tributary that flows to Unnamed Trib South Creek 1 from the south confirmed this watercourse is significantly modified and at the time of inspection was found to be a series of large farm dams that has likely lost all stream function and provides minimal habitat (Figure 16).

Figure 16: Mapped unnamed 1st order tributary modified to a series of farm dams. Photo looking downstream toward Unnamed Trib South Creek 1.

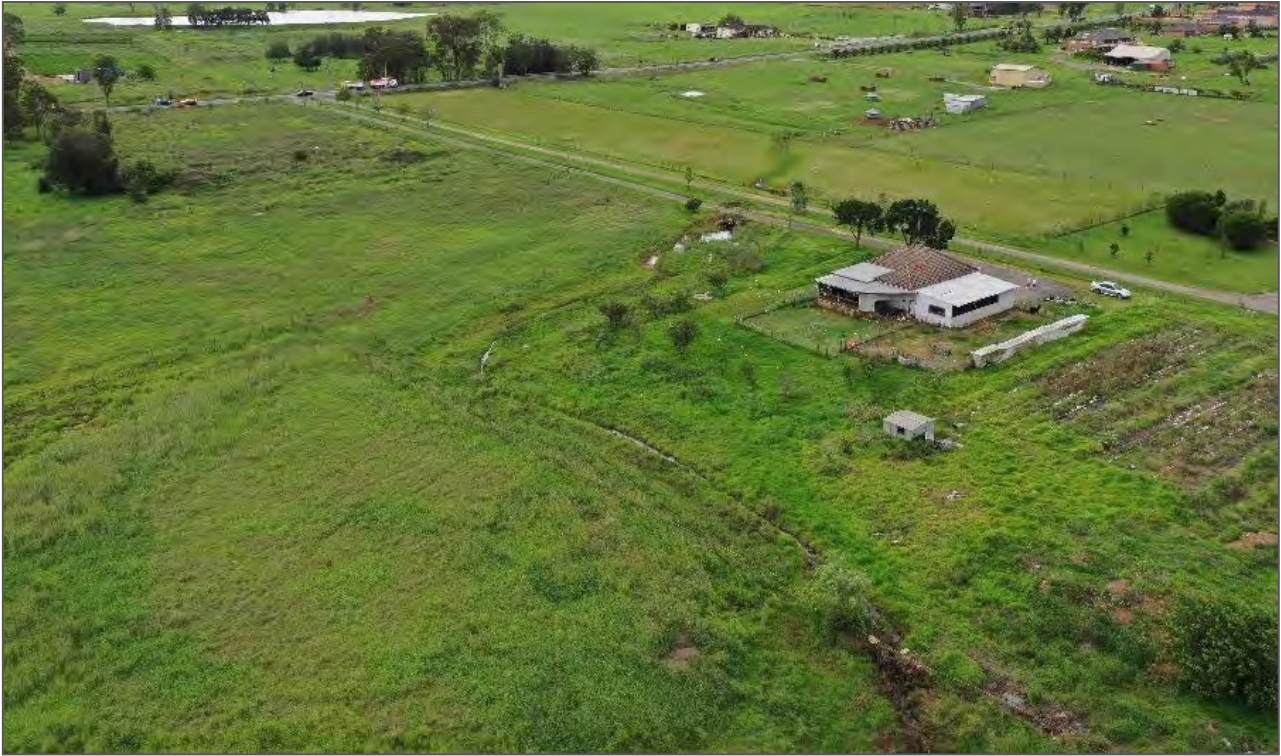
Much of this section of waterway has undergone modification and appeared to be channelised and realigned with bed incision and bank erosion increasing as the waterway approached South Creek (Figure 17). There is

Figure 17: Lower section of Unnamed Trib South Creek 1. Channel modification and erosion is evident.

a lack of native vegetation along the watercourse corridor in the proximity to South Creek and adjacent floodplain however given there is some habitat value in the upstream portion, including a series of farm dams, this waterway has potential to provide a valuable ecological corridor between South Creek and Ropes Creek.

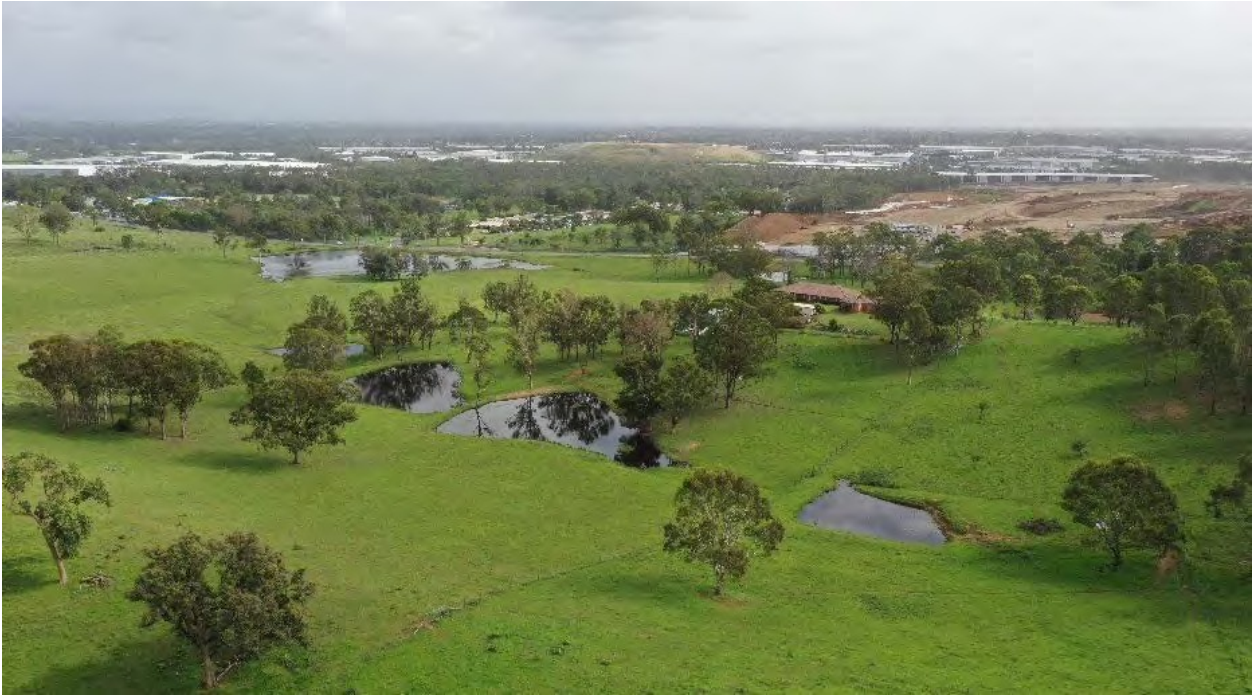
Field inspection of Unnamed Trib South Creek 2 validated the presence of a 1st order watercourse (Figure 24). The upper most section (south of Aldington Road) of this watercourse has been modified to a series of farm dams with overland flow paths providing links across a broad and shallow drainage depression (Figure 19). Fringing and emergent wetland vegetation and large native trees were present around all dams which provide habitat value for native fauna (Figure 20).

Figure 19: Upper section of Unnamed Trib South Creek 2 showing series of farm dams.

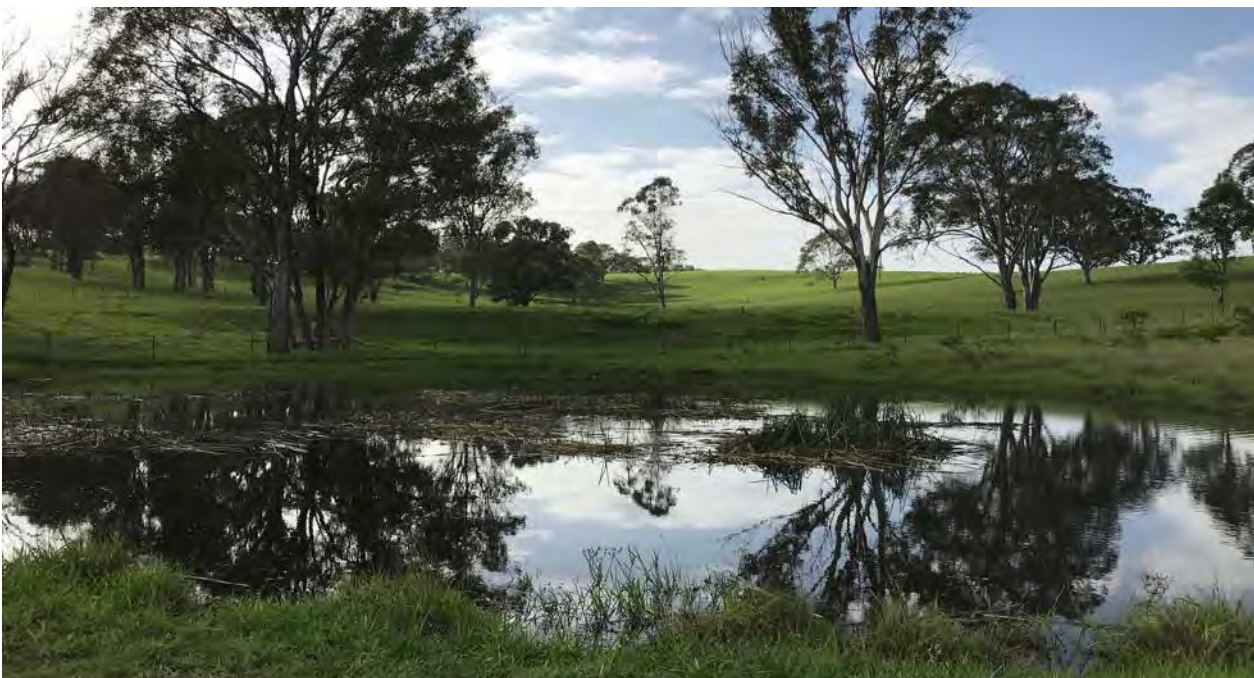
Figure 20: Emergent wetland vegetation and large native trees in upper section of Unnamed Trib South Creek 2.

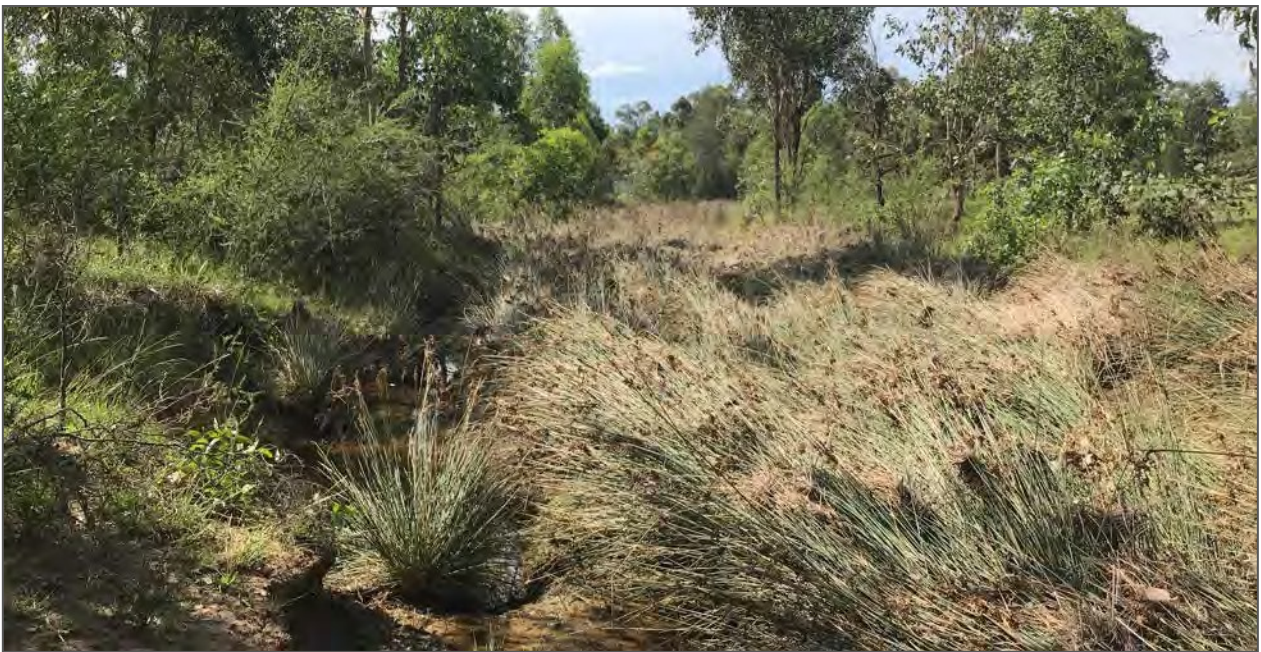
In this section the creek channel has been modified and realigned and a series of dams and diversions were observed at the northern most extent of the Precinct where the Sydney Water pipeline forms the boundary. The section of the channel within the grounds of the school had a heavy infestation of the invasive species *Juncus acutus* (Figure 21) and once the watercourse entered the patch of remnant bushland downstream this became a heavy cover of *Typha orientalis* (Figure 22).

Figure 21: Infestation of *Juncus acutus* in Unnamed Trib South Creek 2.

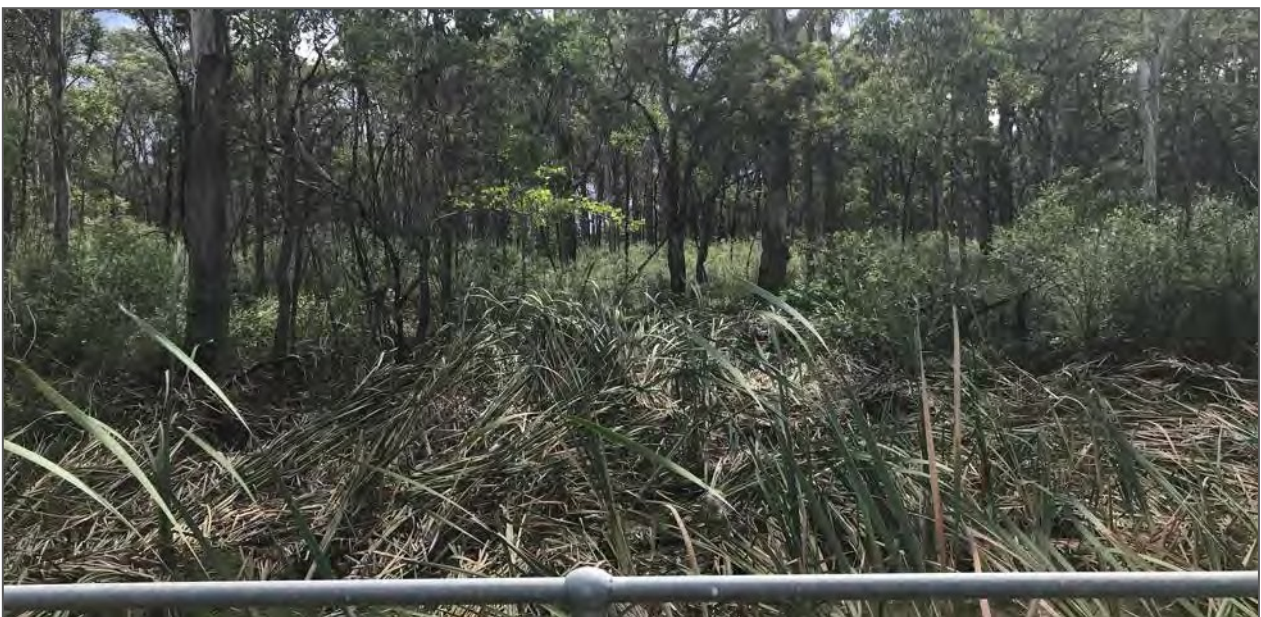
Figure 22: Thick cover of *Typha orientalis* in Unnamed Trib of South Creek 2.

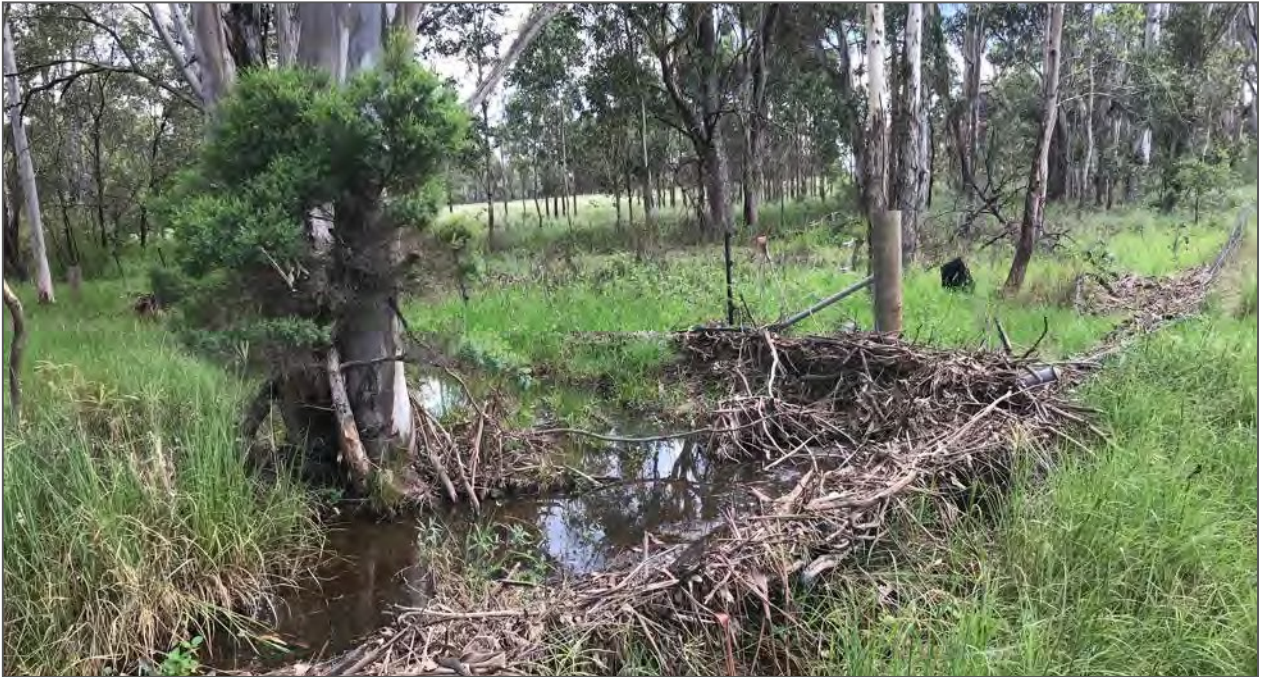
The exit point of the watercourse was difficult to define due to the modified flow path of the lower section which included dams and diversion channels. On inspection it was apparent the watercourse exited the Precinct as a wide depression (Figure 23).

Figure 23: Flow path of Unnamed Trib South Creek 2 at the northern boundary of the Precinct.

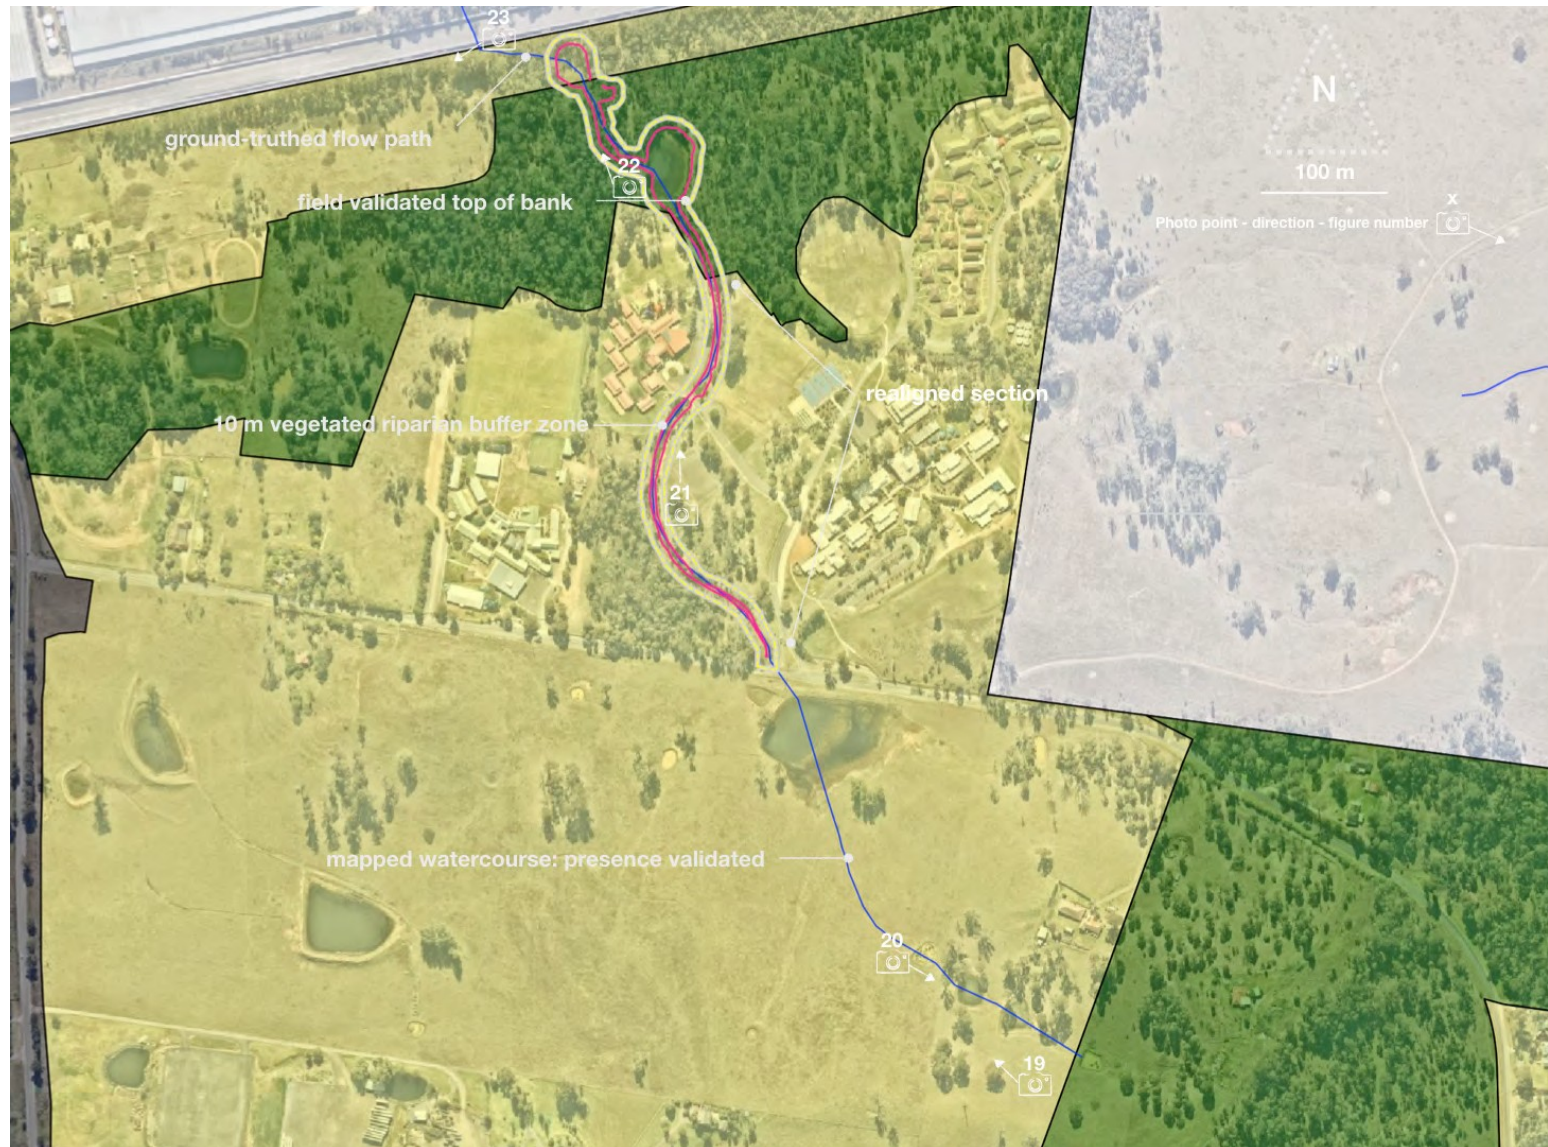
INSET MAP 4

Field inspection of the lower section of Unnamed Trib South Creek Trib 2 validated the presence of a defined bed and bank. As a result, a 10 m Vegetated Riparian Zone is required to be maintained on both banks (Figure 24) as per *NSW Water Management Act 2000*.

Figure 24: Unnamed Trib South Creek 2. Field validated watercourse, mapped top of bank and required Vegetated Riparian Zones.

Unnamed Trib South Creek 2 has high ecological value in the lower portion within the remnant bushland which is proposed to be rezoned as E2. The upper section of this waterway has ecological value as it provides wetland and woodland habitat and has potential to provide an ecological corridor between Ropes Creek and South Creek.

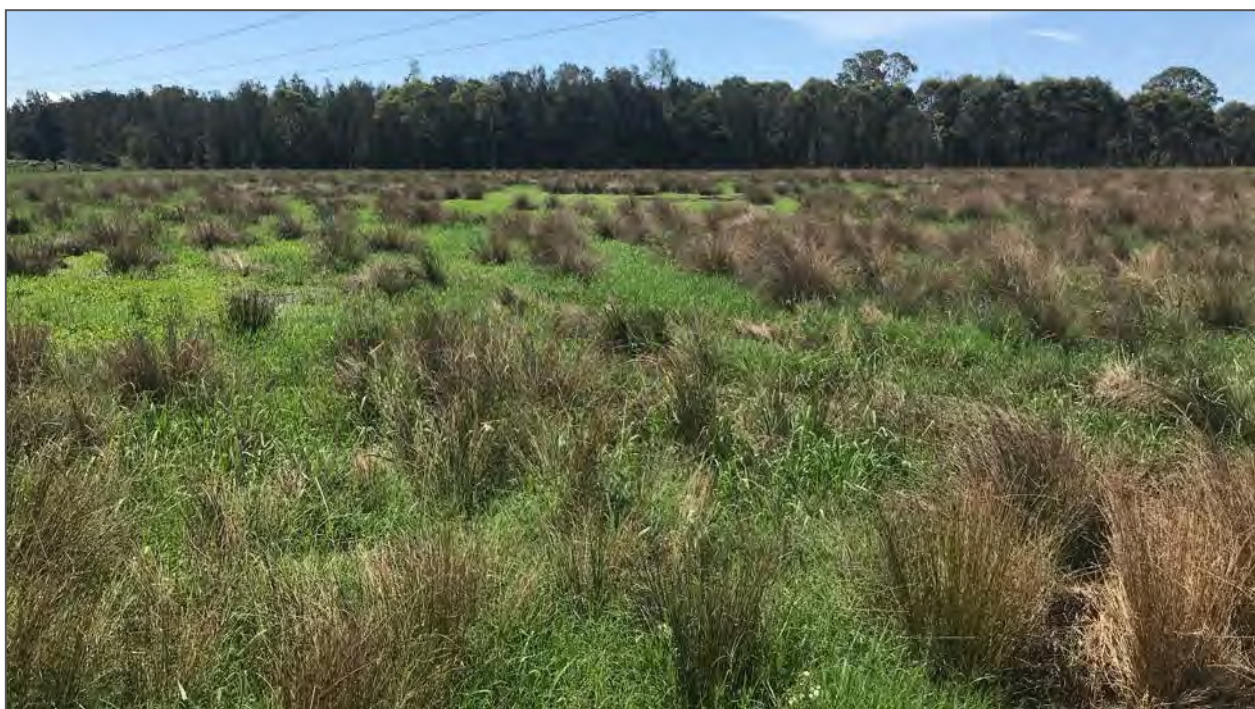
Field assessment recorded the presence of an unmapped wetland with an area of approximately 0.5 ha between Ropes Creek and Unnamed Trib Ropes Creek (Figure 25). This wetland had a thick cover of native wetland vegetation and lies in a shallow depression adjacent to a large online farm dam on Unnamed Trib Ropes Creek. The extent of the wetland was mapped and as a result a 40 m Vegetated Riparian Zone is required as per *NSW Water Management Act 2000* (Figure 30).

Figure 25: Unmapped wetland looking north towards Ropes Creek corridor.
