Appendix F Riparian Corridor Management Plan

Mamre Road Precinct Rezoning: Waterway Assessment

Kemps Creek and Mount Vernon

Prepared for: Sydney Water

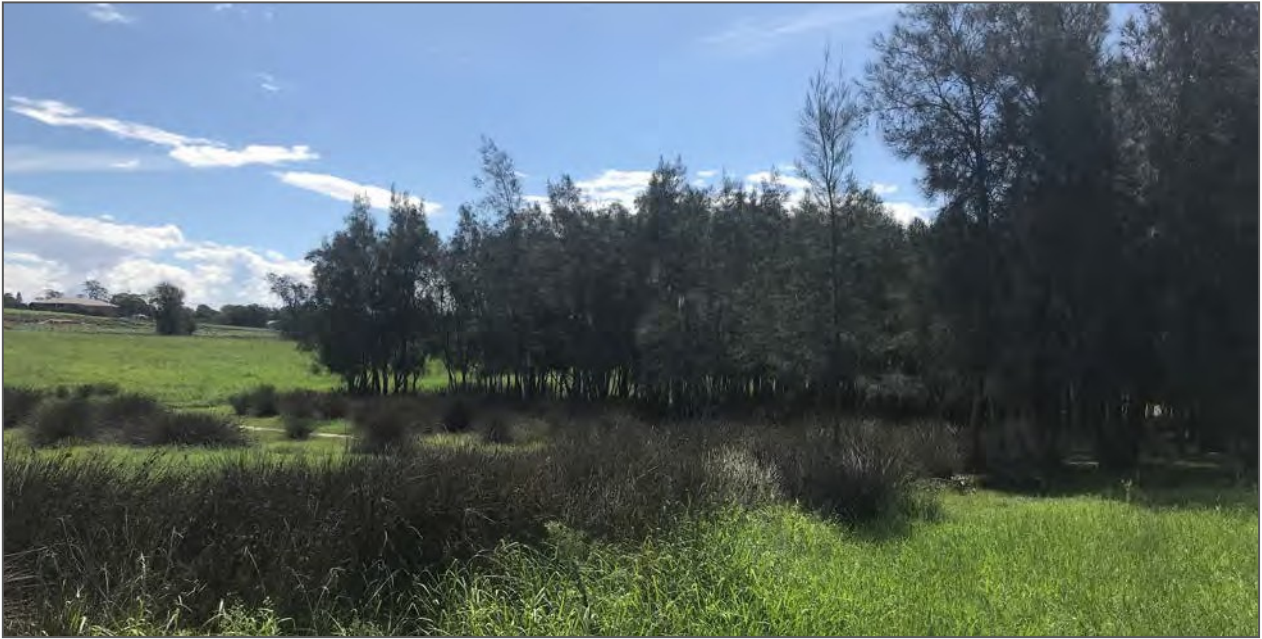
The majority of the flow path of Unnamed Trib Ropes Creek has been modified to a series of farm dams (Figure 30). Where a channel exists between dams, heavy infestation of the invasive weed *Juncus acutus* was evident (Figure 26). However, at the time of assessment there was a diverse matrix of native fringing and emergent wetland plants within these farm dams and patches of *Casuarina glauca* scattered across the site (Figure 27).

Figure 26: Unnamed Trib Ropes Creek with infestation of *Juncus acutus* and patch of *Casuarina glauca*.

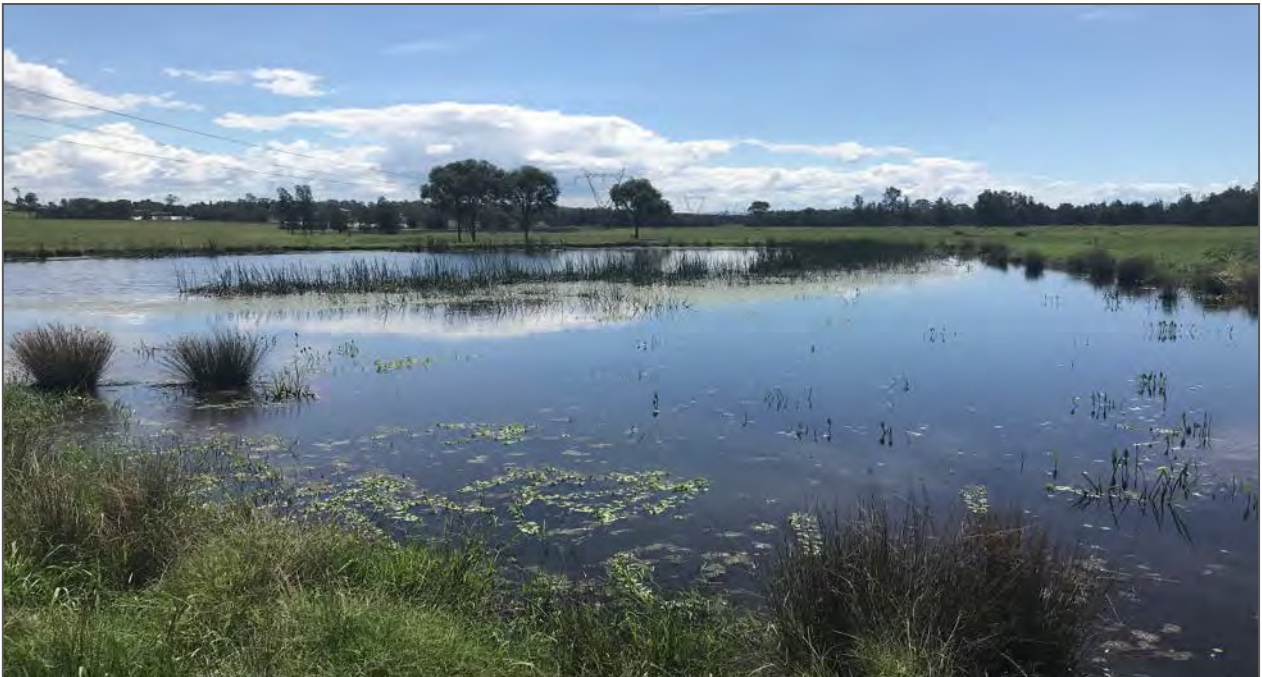
Figure 27: Unnamed Trib Ropes Creek online farm dam with emergent and fringing wetland vegetation.

combination of Industrial, Private Recreation and Environmental Conservation. Given the habitat value of the online dams and wetland on and adjacent to this watercourse consideration should be given to zoning that offers protection of this waterway.

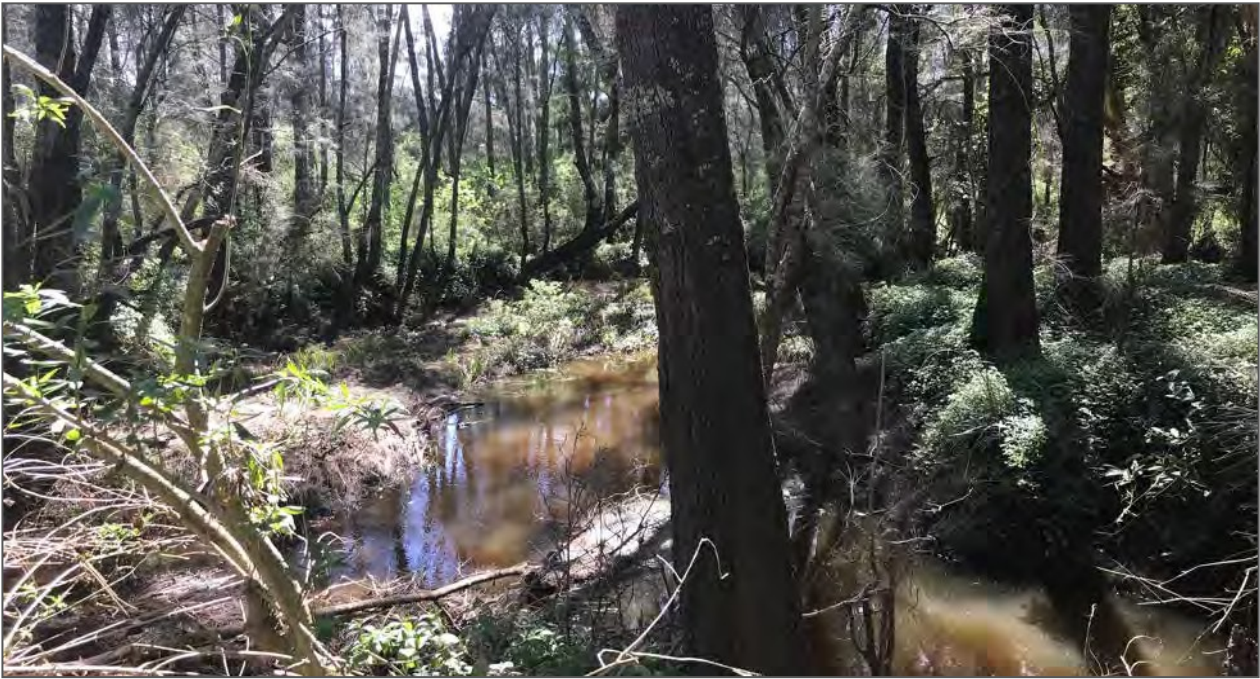
In the lower section of the watercourse, upstream of the Ropes Creek confluence the flow path widened in places and root supported knick points were evident in a dense stand of *Casuarina glauca* which protects the channel from accelerated erosion (Figure 28).

Figure 28: Widened channel upstream of Ropes Creek confluence.

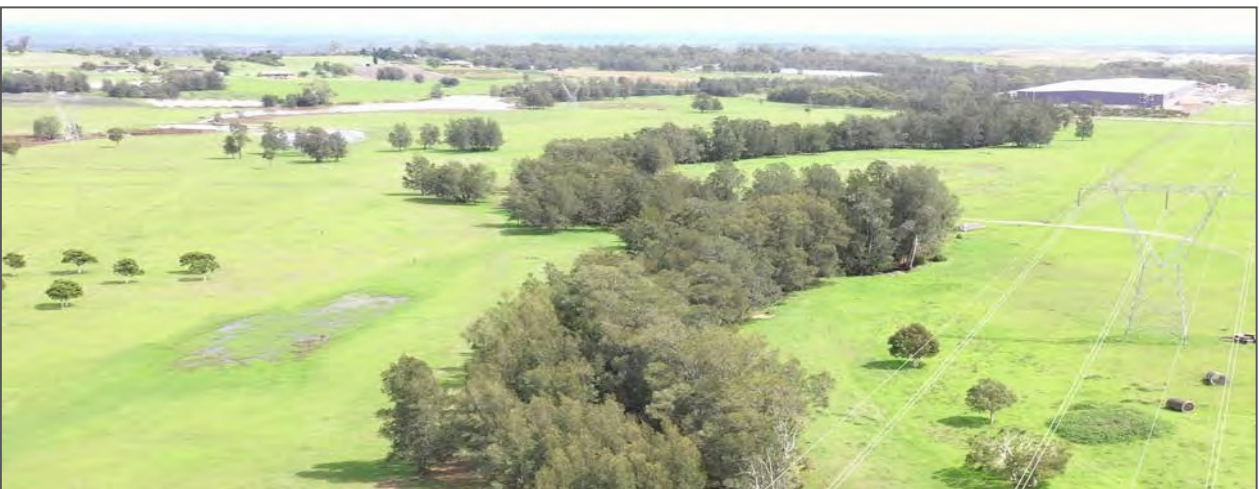
Figure 29: Ropes Creek corridor looking north west (downstream). Unnamed Trib Ropes Creek can be seen as a series of online dams to the left of the photo.

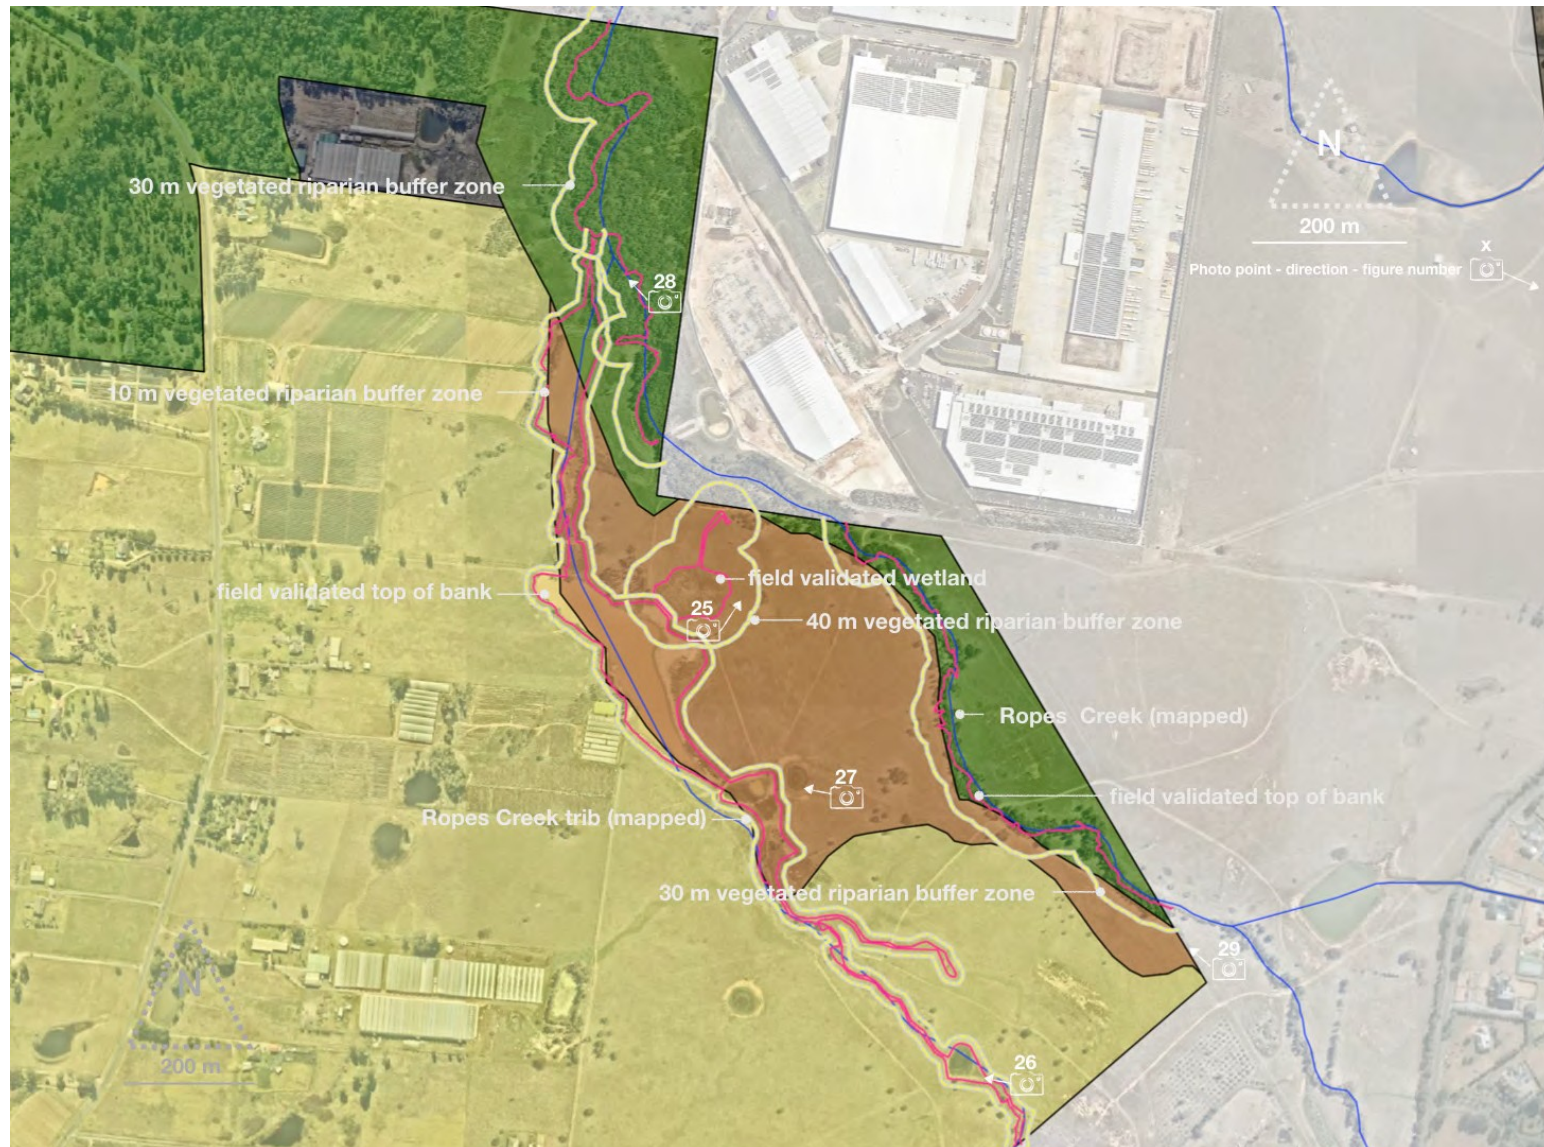
INSET MAP 5

Ropes Creek was field validated as a 3rd order stream and Unnamed Ropes Creek Trib was field validated as 1st order. Both waterways had a defined bed and bank and therefore top of bank was mapped (Figure 30). As a result a 30 m Vegetated Riparian Zone is required on Ropes Creek and 10 m Vegetated Riparian Zone is required on each bank of Unnamed Trib Ropes Creek (Figure 30) as per *NSW Water Management Act 2000*.

Assessment of Ropes Creek validated the presence of a defined bed and bank which has undergone accelerated erosion due to land use change and the associated changes to stream hydrology. The banks of Ropes Creek are vegetated by dense stands of *Casuarina glauca* (Figure 29) however for a large portion of the creek this is restricted to a narrow strip which is less than the extent of the 30 m Vegetated Riparian Zone (Figure 30) as per *NSW Water Management Act 2000*.

Figure 30: Ropes Creek and Unnamed Ropes Creek Trib. Field validated watercourse, mapped top of bank and required Vegetated Riparian Zones.

The Ropes Creek corridor has ecological value as it contains endangered ecological communities and species and provides habitat and a movement corridor for native fauna species. The proposed rezoning has included the Ropes Creek corridor as Environmental Conservation. However, the extent of the proposed zoning does not include the full width of the 30 m Vegetated Riparian Zone and therefore consideration should be given to expand the Environmental Conservation zone to accommodate the full Vegetated Riparian Zone.
