WAGGA WAGGA SPECIAL ACTIVATION PRECINCT

PRELIMINARY SITE INVESTIGATION

NOVEMBER 2019

Wagga Wagga Special Activation Precinct Preliminary Site Investigation

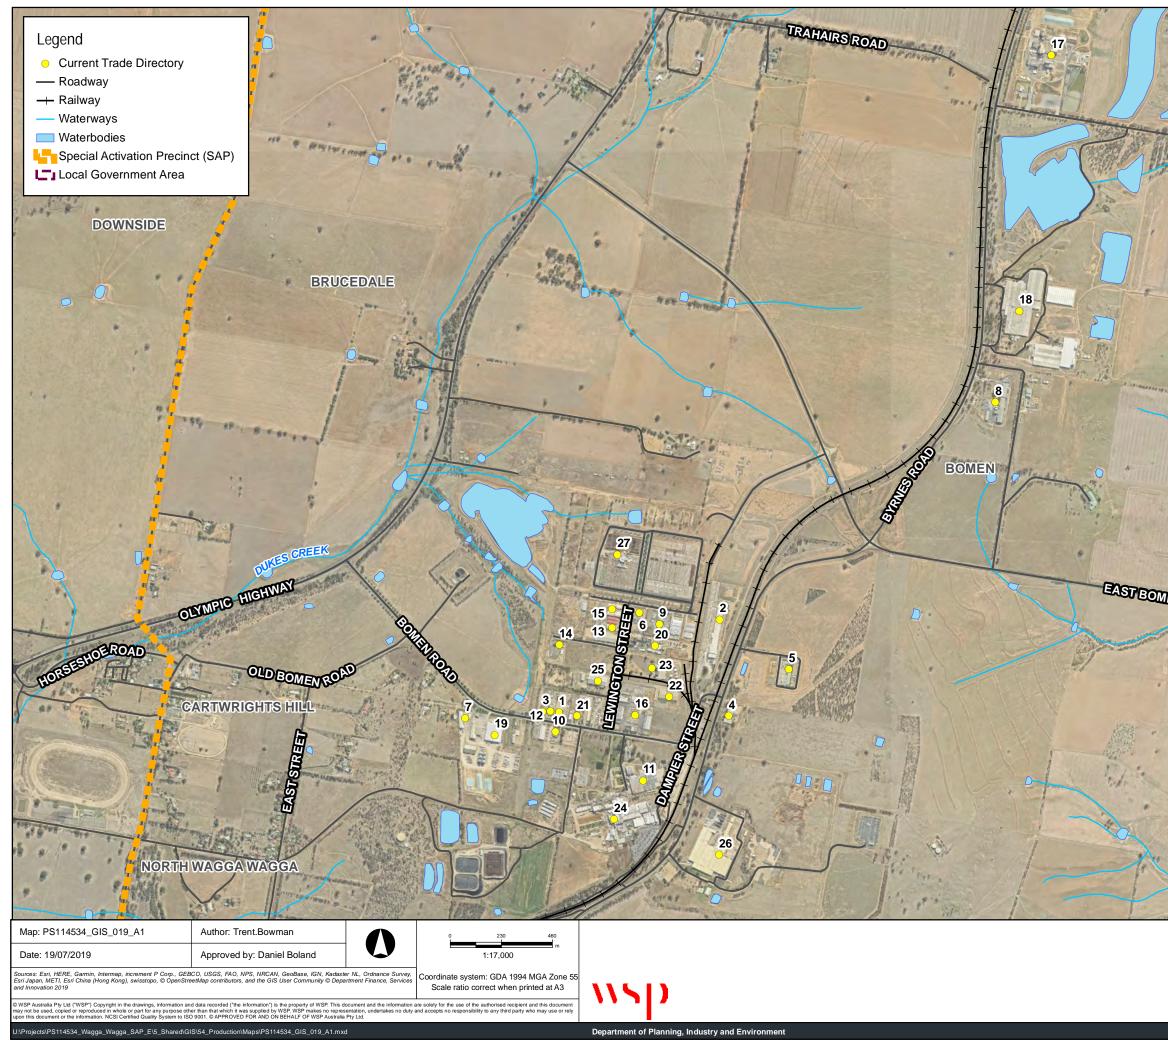
Figure 1

Current businesses

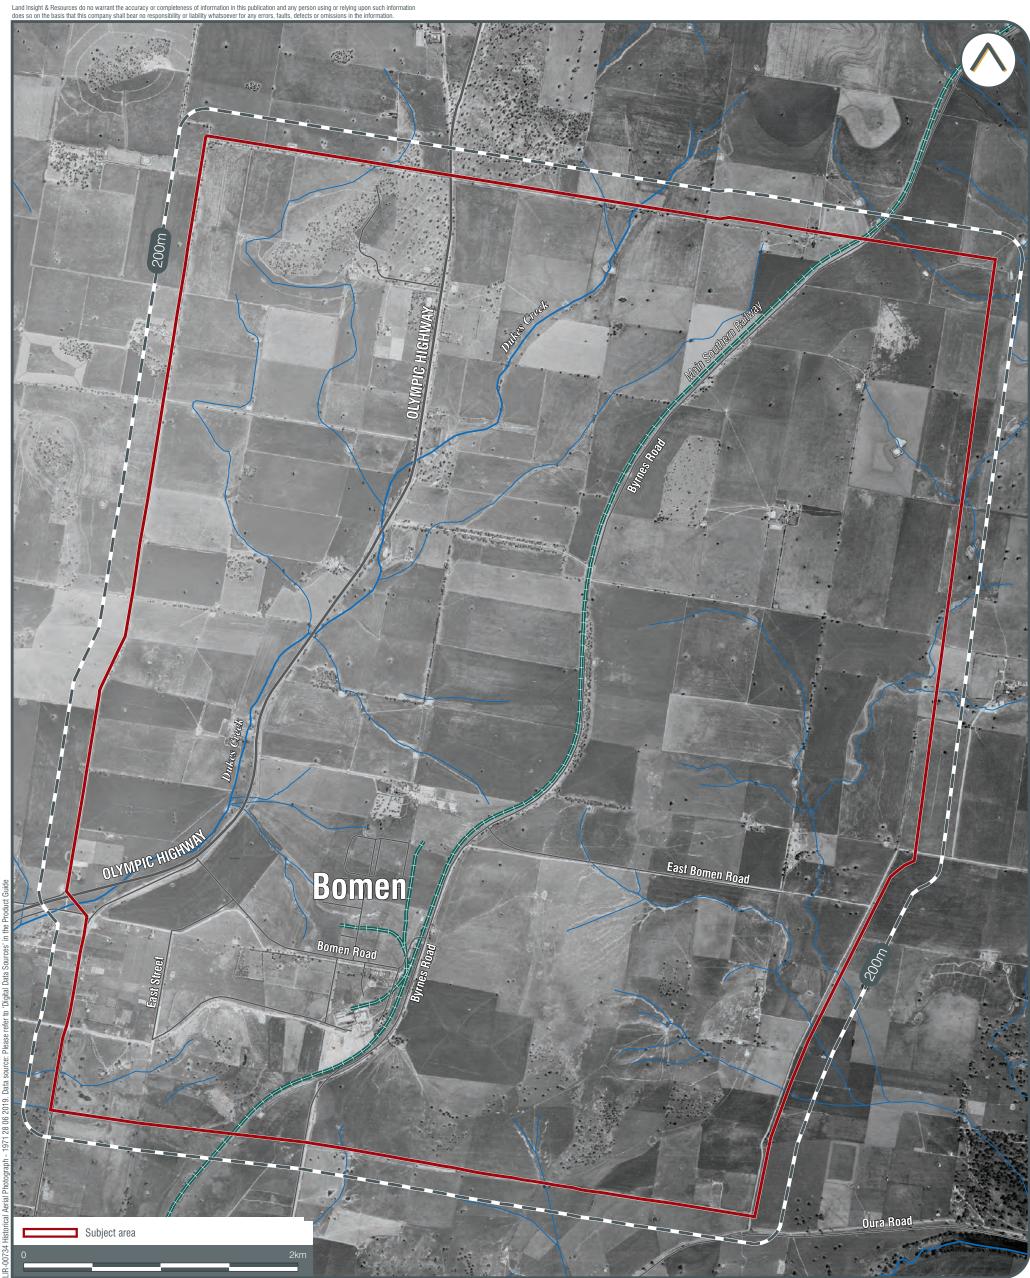
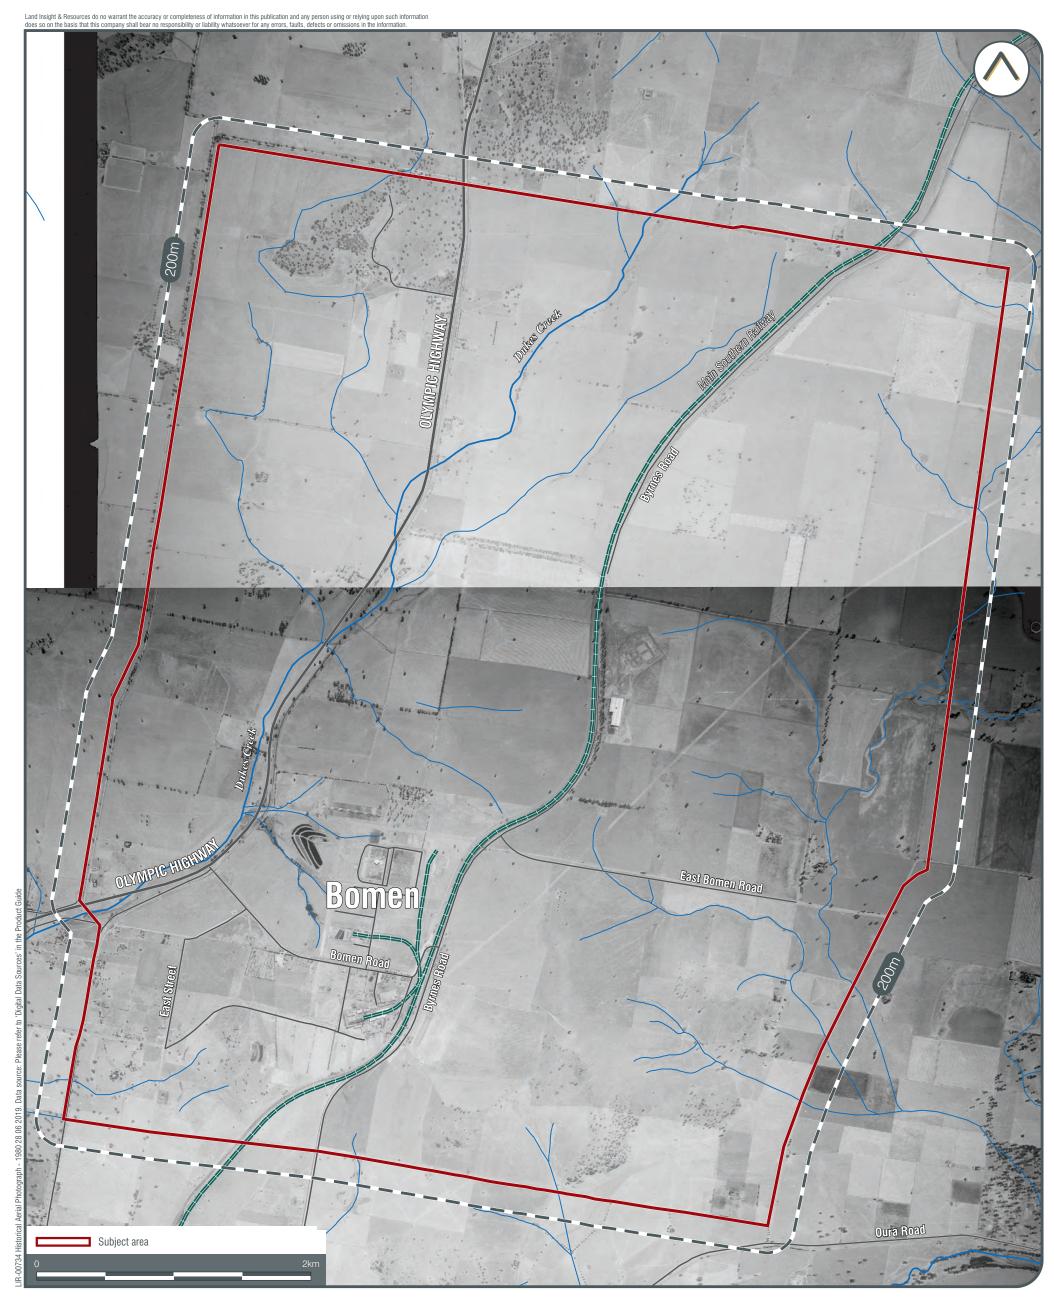
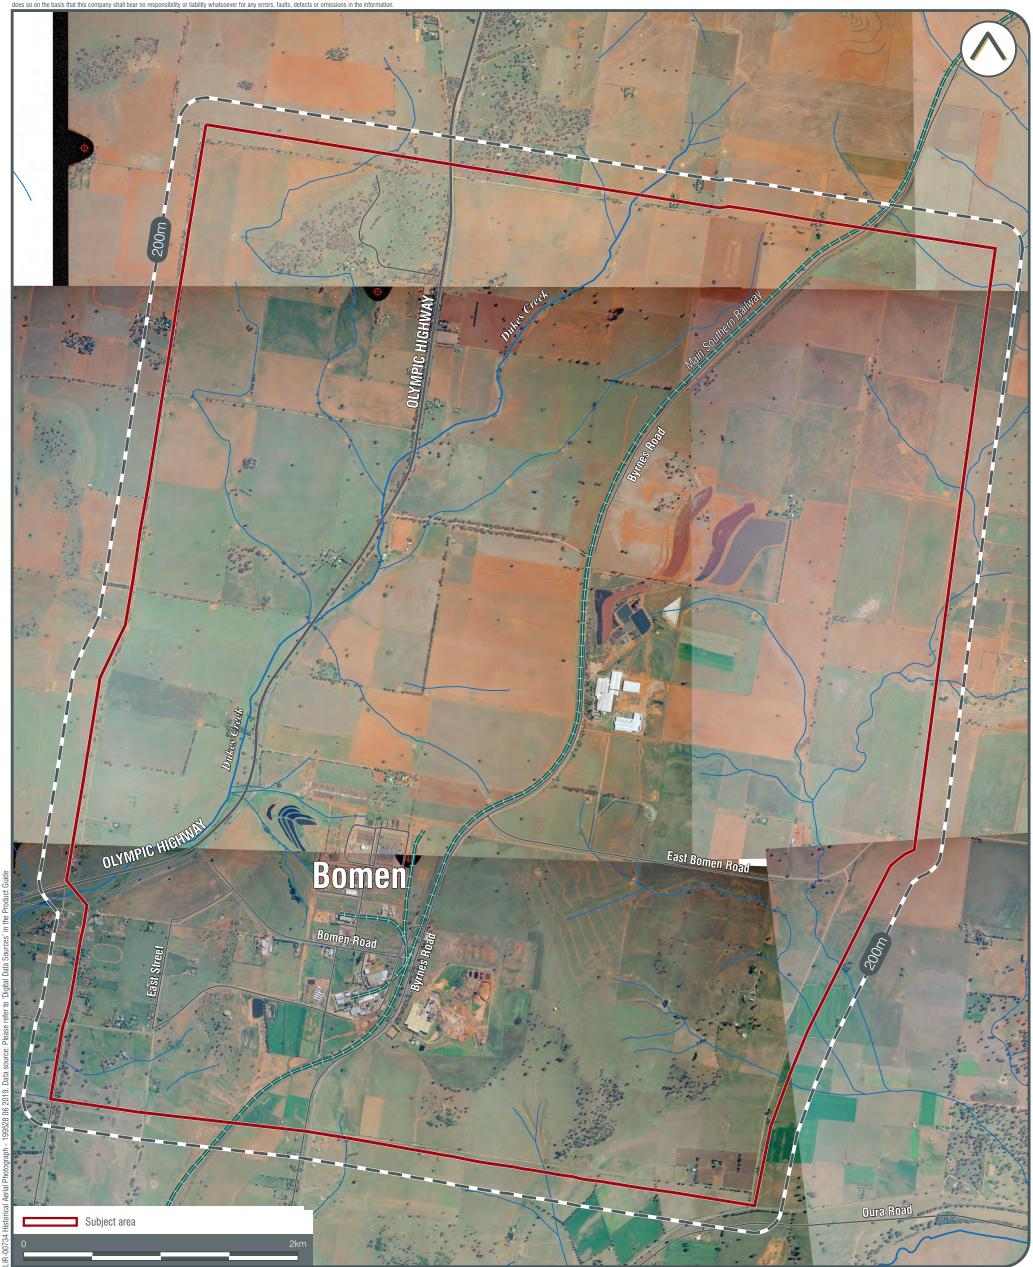
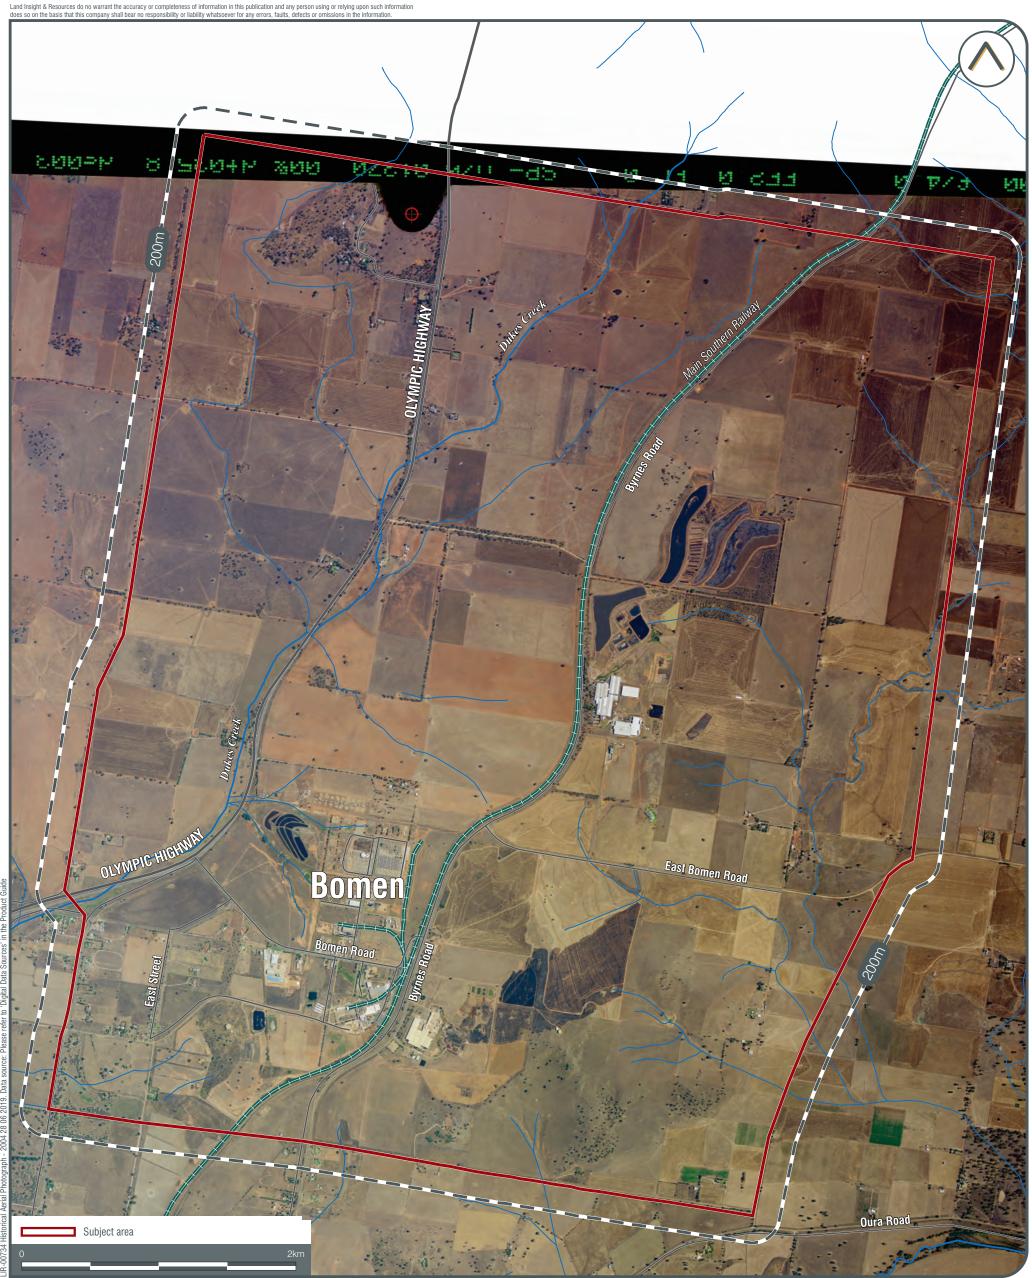
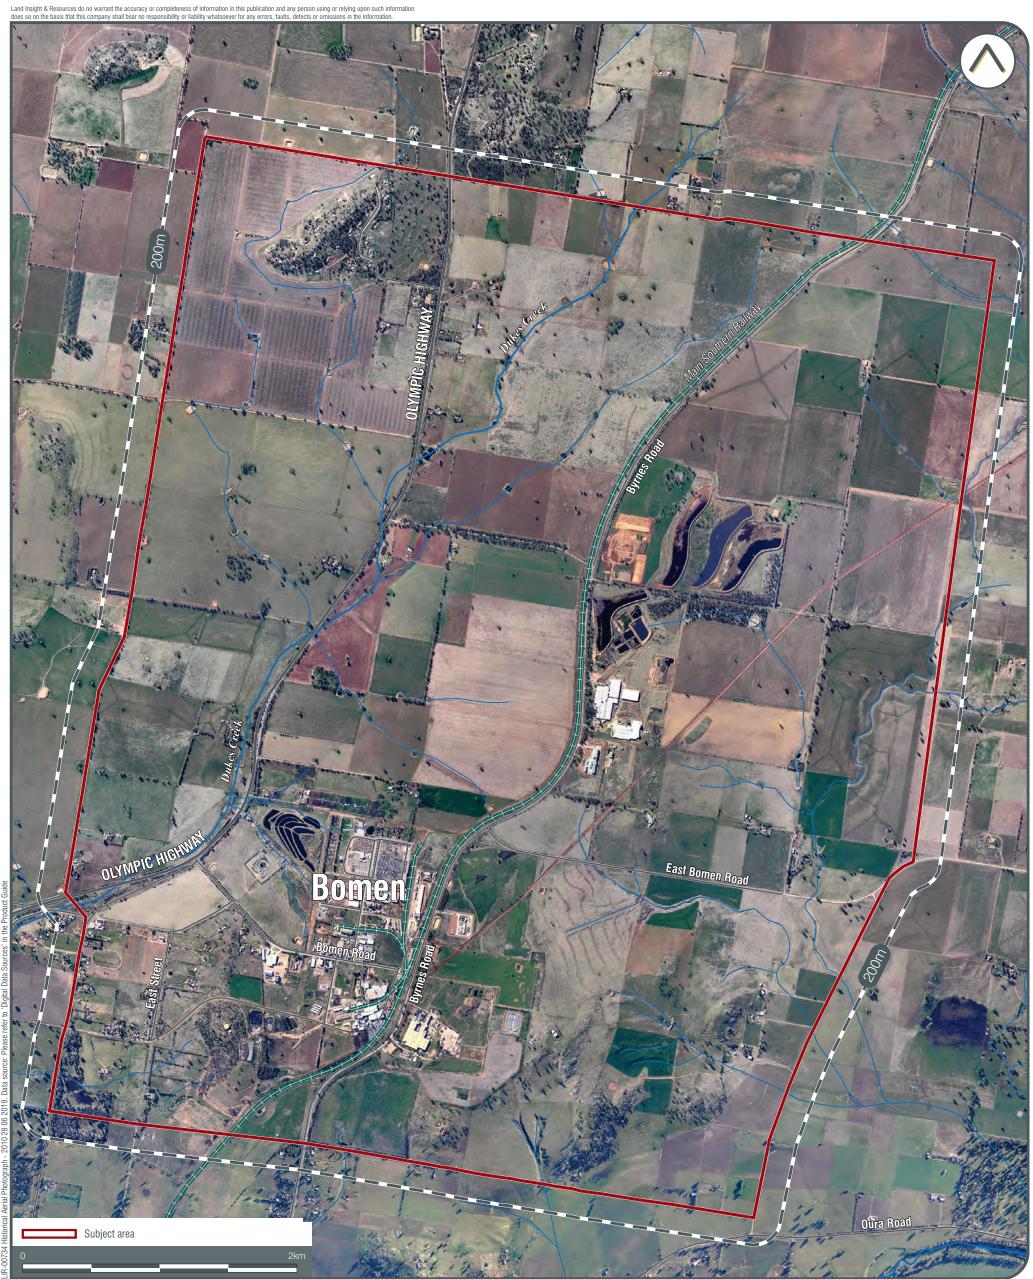
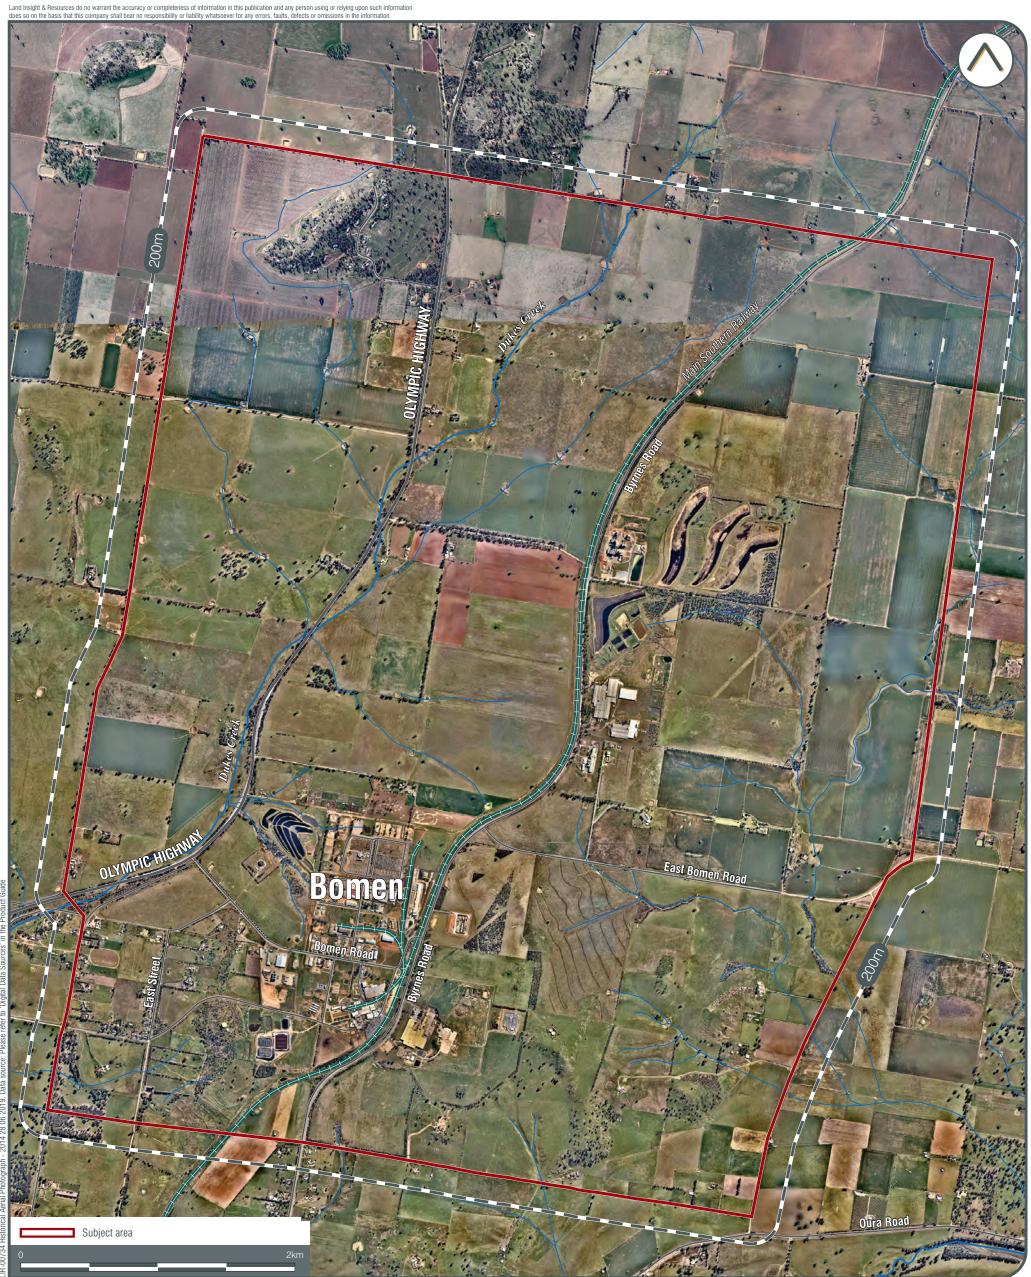
APPENDIX B AERIAL PHOTOS

A review of historical aerial photography covering the site and surrounding area was undertaken with a summary of the observed land use changes described in Table 2.5. Historical aerial photographs are presented in Appendix B.

YEAR	ONSITE OBSERVATIONS	SURROUNDING LAND OBSERVATIONS
1971	Area of investigation is generally vacant/farmland. The Main Southern railway line runs through the area in its current alignment. Buildings are present in the current location of the Teys abattoir. Residential dwellings are present along Bomen road close to the railway line. Orchards appear to be present to the west of the residences. The Olympic Highway and Byrnes road are visible within the investigation area.	Surrounding land is generally vacant/farmland.
1980	 An additional building is present, in the current location of the Heinz Watties facility. The orchards from the previous image have reduced in size. A shed has been built in the Bomen industrial estate. Development has occurred at the Wagga Wagga Livestock Marketing Centre and its associated ponds have been constructed. A shed-like building is present at the wool combing facility site. Residential development of Cartwrights Hill has started. 	The image is generally consistent with previous image.

1995	 There is further development of lots within the Bomen industrial precent to the west of the railway line, including the construction of the Caltex fuel depot. The ponds linked to the abattoir have been constructed. East of the railway line, the lot where Vinidex is currently present has been developed to its current configuration and there is significant land disturbance to its east. Land to the north-east of the Vinidex facility has been recontoured. The ponds associated with the wool combing facility have been constructed as have more buildings. 	Consistent with previous image.

YEAR	ONSITE OBSERVATIONS	SURROUNDING LAND OBSERVATIONS
	There is further residential development of Cartwrights Hill. The residential development of the north-west of the investigation area has commenced.	
2004	There is further development of lots within the Bomen industrial precent to the west of the railway line, including the Southern Oil facility and the Rodney's Transport facility. A small building has been constructed to the south of the wool combing facility. The land on the southern corner of the Byrnes Road and East Bomen Road has been recontoured.	Consistent with previous image.
2010	There is further development of lots within the Bomen industrial precent to the west of the railway line. The wastewater treatment plant south-west of the livestock marketing centre ponds has been constructed. The electrical substations present in the industrial area, to the west of the abattoir and to the east of Vinidex facility have been constructed. The BOC facility to the west of Byrnes Road has been constructed. Another building has been constructed to the south of the wool combing facility. Construction is underway at the ROBE facility.	Consistent with previous image.

A linear trench crossing several blocks can be seen in the investigation area to the east of the railway line. It is believed that this is a gas pipeline installation.	
	The residential development in the north-west of the investigation area appears to be in its current form.	
2014	There is further development of lots within the Bomen industrial precinct to the west of the railway line.	Consistent with previous image.
2019	Land use is largely consistent with the previous image.	Consistent with previous image.

Based on the historical images the majority of the investigation area has been vacant/farmland from at least 1971. The present Teys abattoir building was present in the earliest reviewed aerial photograph from 1971. Development of the Bomen industrial precinct to the west of the railway continued over the following decades, with major land users including the Wagga Wagga Livestock Marketing Centre (present from 1980), the Caltex/Tasco fuel depot (from 1995) and the Rodney's Transport facility (from 2004).

To the east of the railway line, development is visible from 1980, with a building present at the historic wool combing facility location. Development continued in subsequent decades, with major features including the wool combing ponds, what is currently the Vinidex facility, the battery recycling facility buildings and the ROBE facility.
