Report on
Geotechnical Investigation

Proposed Commercial Development
8-10 Lee Street, Haymarket

Prepared for
Atlassian Pty Ltd

Project 86767.00
August 2019

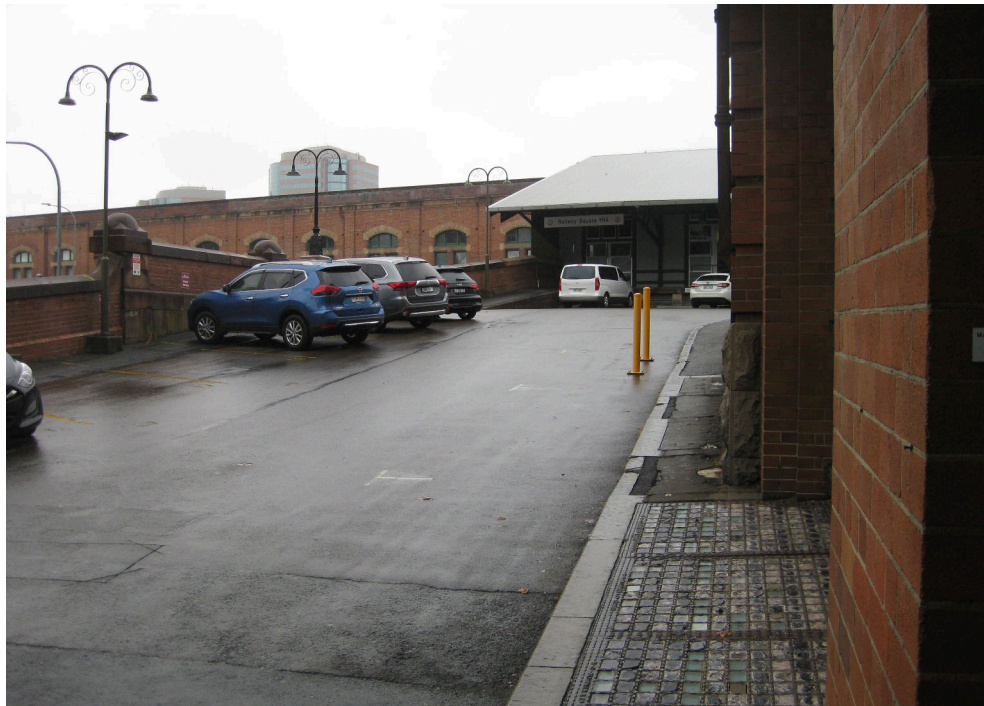
Photo 1 – View east along Upper Carriage Lane towards the YHA building (Adina Hotel to the right of the field of view), with Central Station in the background.

- Central and Western area of the site ('State Works - Link Zone'):
 - o This area includes an asphalt-surfaced, open-air, access ramp/road (ie Upper Carriage Lane, at approximate Upper Ground Floor level) which connects with Lee Street to the west (refer Photos 1 and 2 on Plate 1, Appendix B);

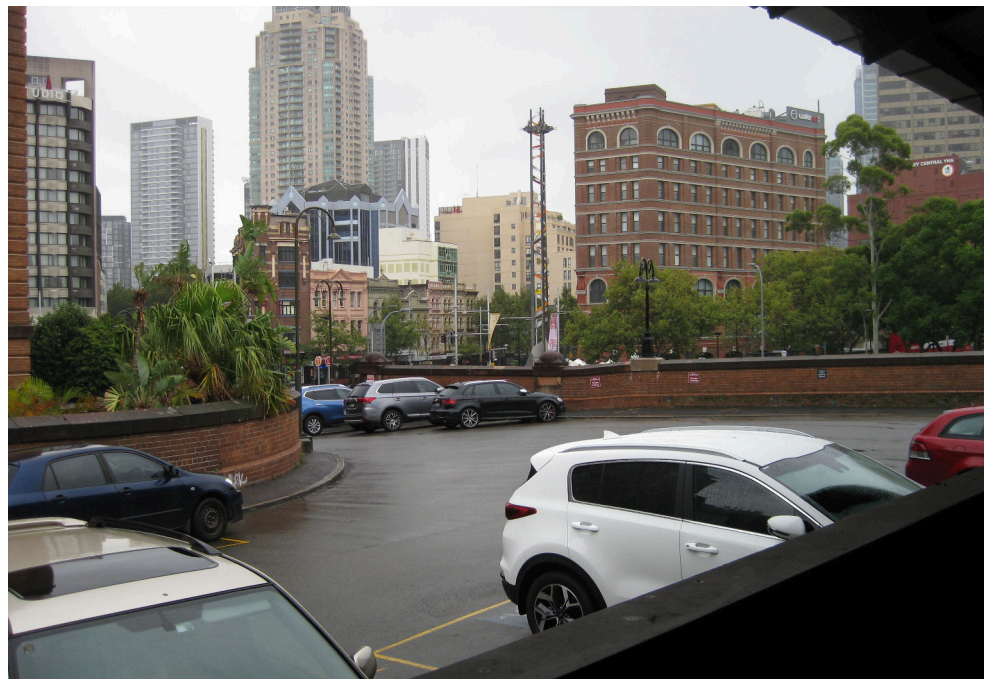
Photo 2 – View north across the asphalt-surfaced carpark towards Lee Street, from the western side of the YHA building (Upper Ground Floor level).

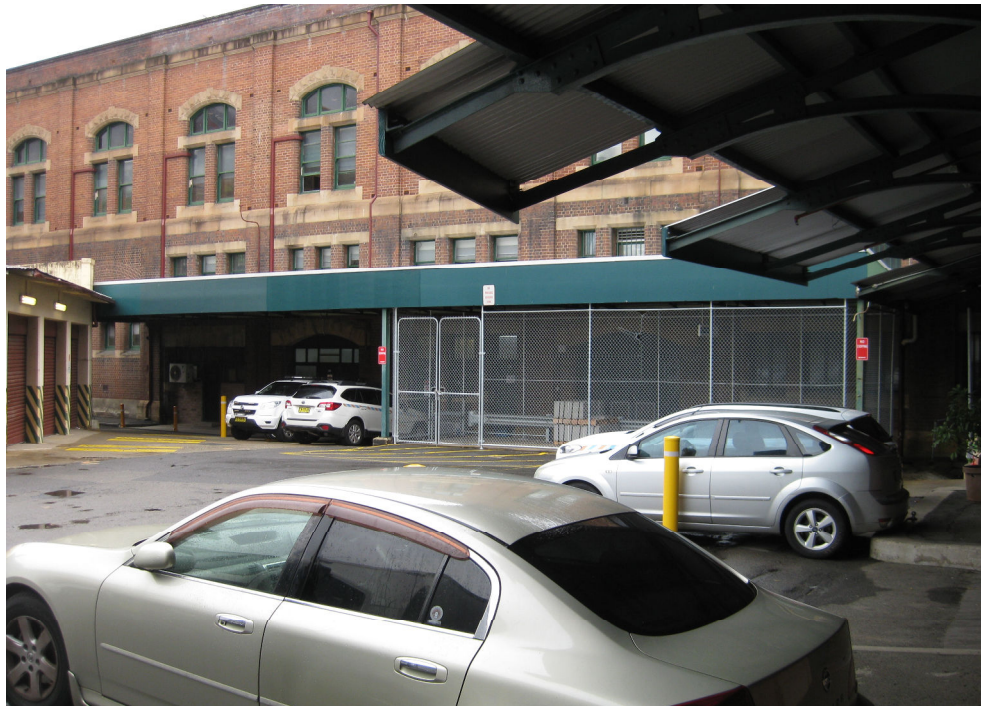
Photo 3 – View to the east from Ambulance Avenue / Lower Carriage Lane, located west of Central Station (visible in the background), and north of both the YHA building and a rail catering facility (at Lower Ground Floor level).

- o The eastern part of this area is suspended above an access corridor, areas of material storage and other facilities, which are accessed from Ambulance Avenue at Lower Ground Floor level (refer Photo 3 on Plate 2 for a general site view): the western part of the access ramp/road is assumed to be underlain by soil fill materials;

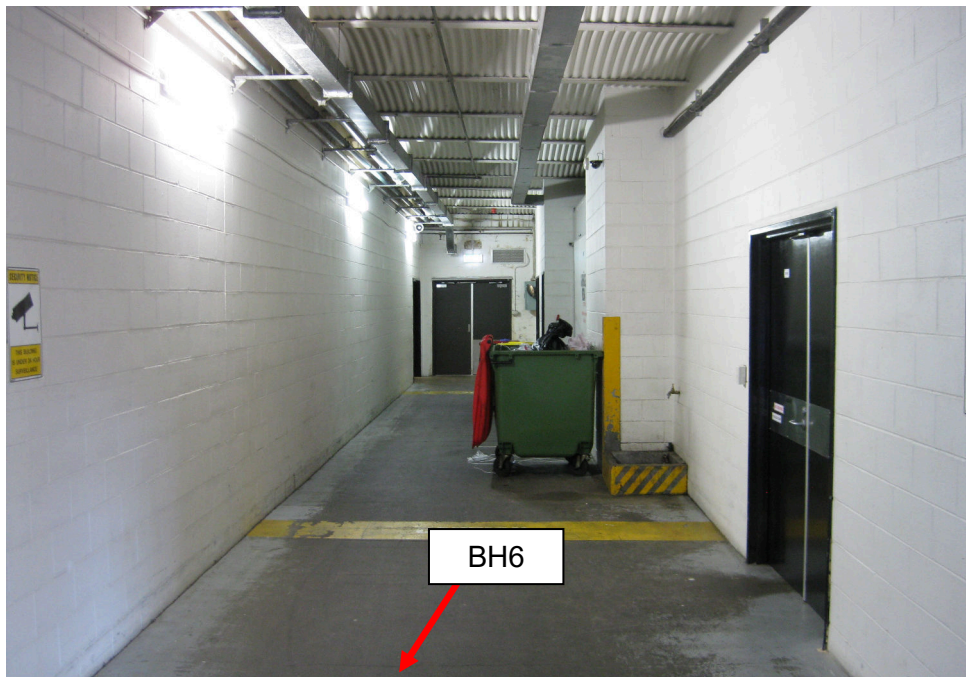
Photo 4 – View south-west along an access corridor from Ambulance Avenue, west of the rail catering facility (Lower Ground Floor level). The location of Borehole BH6 is indicated as shown. Bin rooms and other facilities are present to the right of the field of view, and the rail catering facility is obscured behind the left-hand wall of the access corridor.

- o The access corridor, aligned in an approximately north-east / south-west direction (refer Photo 4, Plate 2), connects Ambulance Avenue with Henry Deane Plaza (to the south). Toilet and bin room facilities were observed on the western side of the access corridor, whilst a materials storage area was present adjacent to the corridor (refer Photos 5 and 6 on Plate 3).

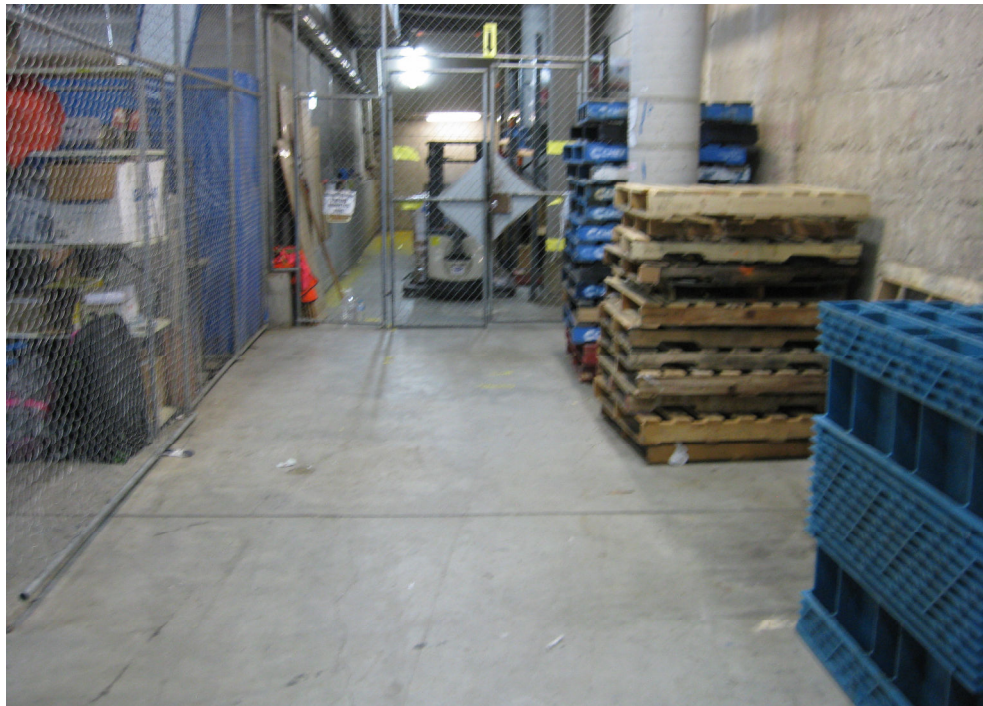
Photo 5 – General view south-west within a storage area adjacent to the access corridor (Lower Ground Floor level).
The position of Borehole BH8 is to the right and behind the field of view.

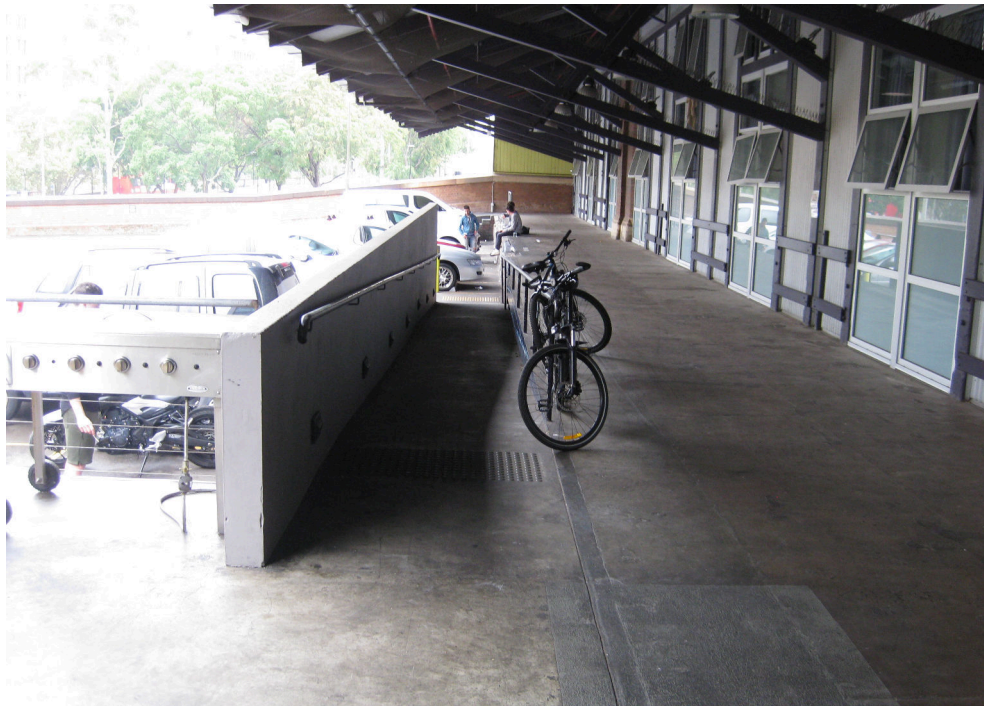
Photo 7 – View north-east along the western side of the YHA building from Upper Carriage Lane (Upper Ground Floor level), in the direction of Ambulance Avenue.

- o Four former rail carriages are present on the eastern side of the YHA building, mounted on steel rails which are apparently supported by grey rail ballast and soil. These carriages, modified to become dormitory rooms / accommodation, are accessed from a concrete-surfaced platform (refer Photos 7 to 9 on Plates 4 and 5);

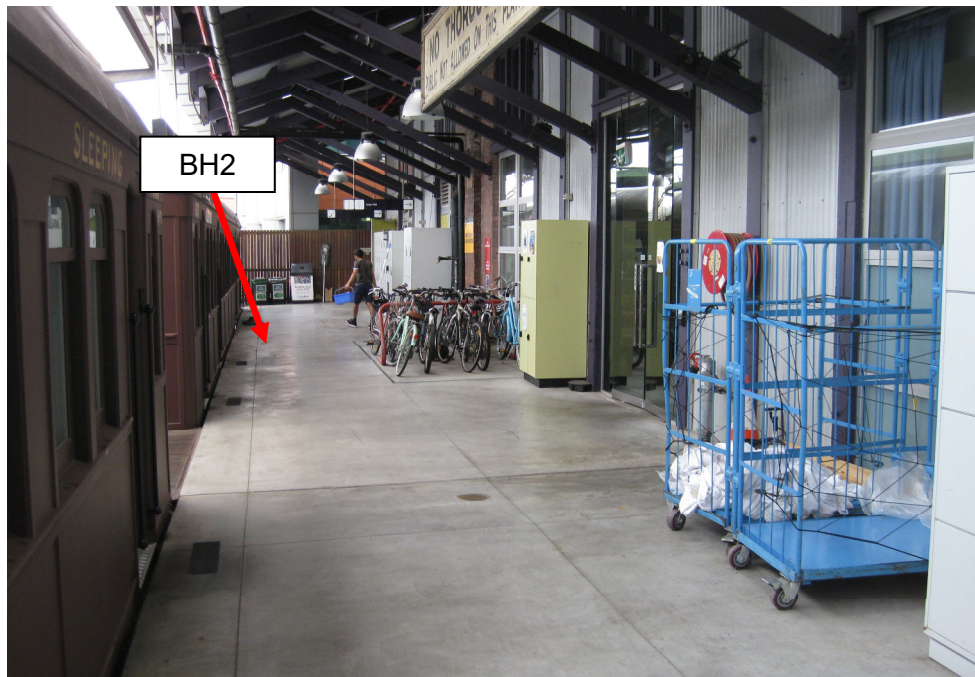
Photo 8 – View south-west along a former rail platform, on the eastern side of the YHA building (Upper Ground Floor level). Carriage dormitories are present to the left of the field of view. The location of Borehole BH2 is indicated as shown.

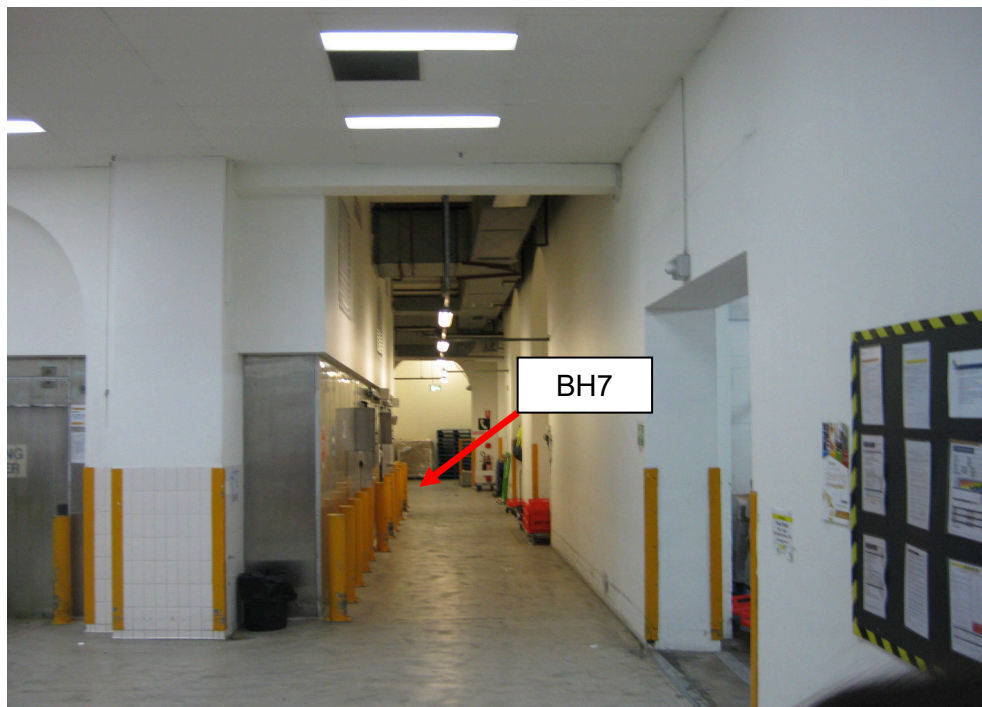
Photo 11 – View south-west within the rail catering facility (Lower Ground Floor level), with the general location of Borehole BH7 indicated as shown. Commercial freezers are present on the left of the field of view.

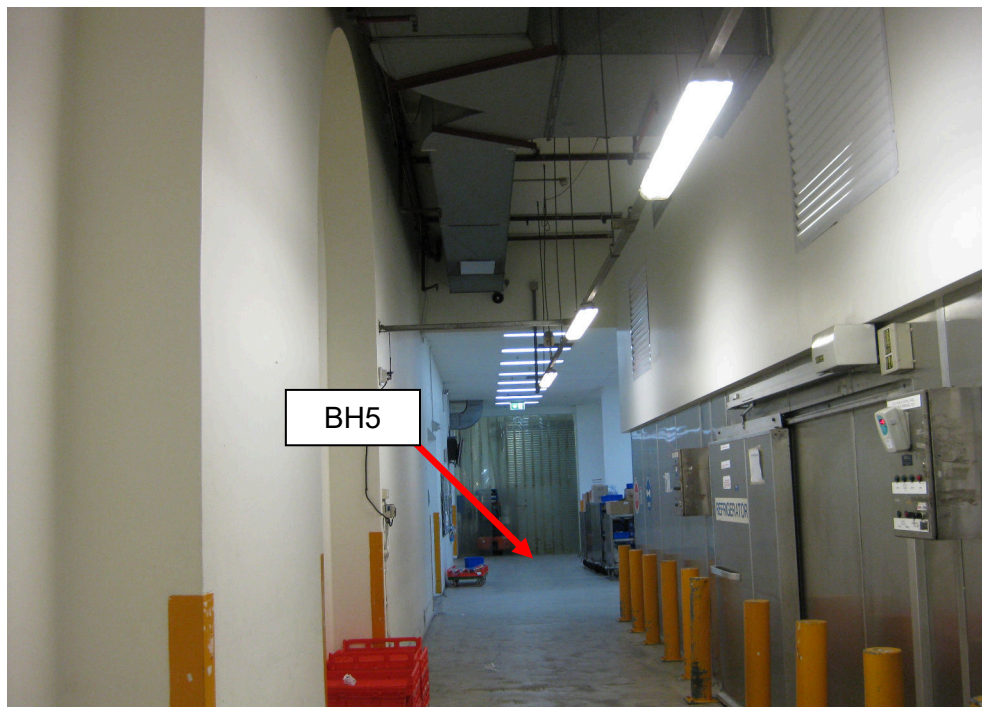
Photo 13 – View north-east within the rail catering facility towards Ambulance Avenue (Lower Ground Floor level). The location of Borehole BH5 is indicated as shown. Commercial freezers are present on the right of the field of view.

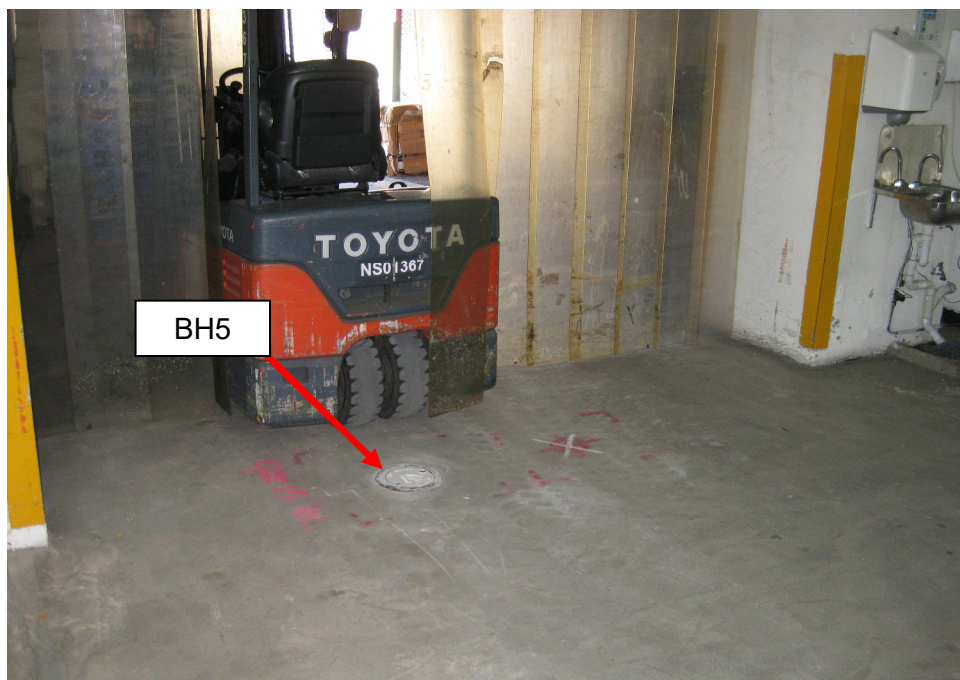
Photo 14 – View to the north-east at the location of Borehole BH5, indicated as shown. A metal lid covers the hole, below which a standpipe piezometer has been installed.

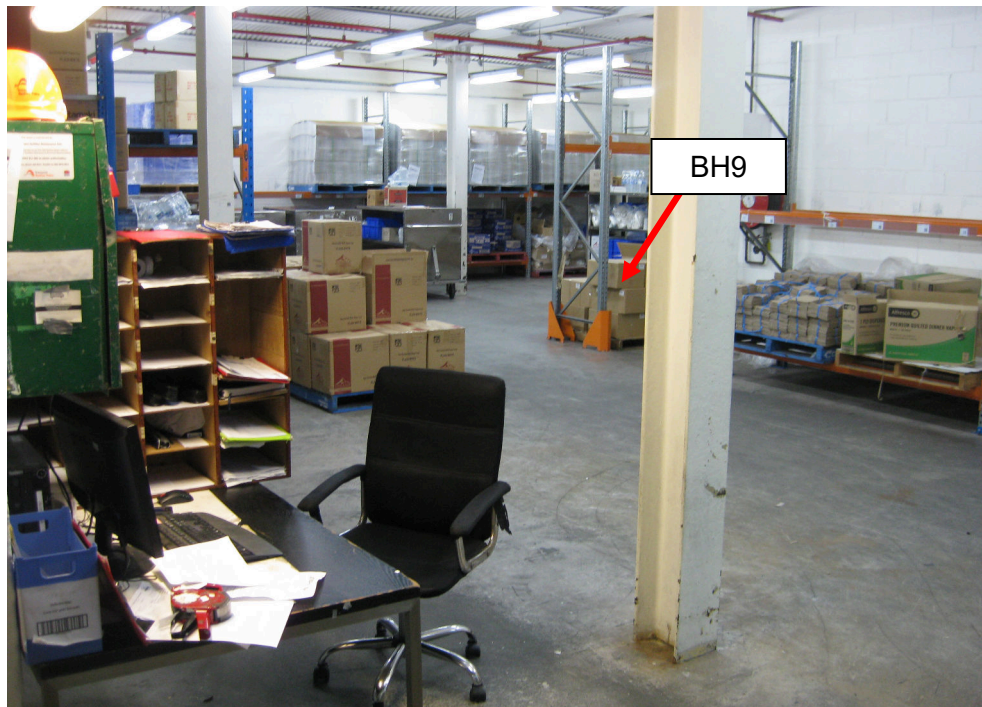
Photo 15 – View west within the rail catering facility, with the location of Borehole BH9 indicated.

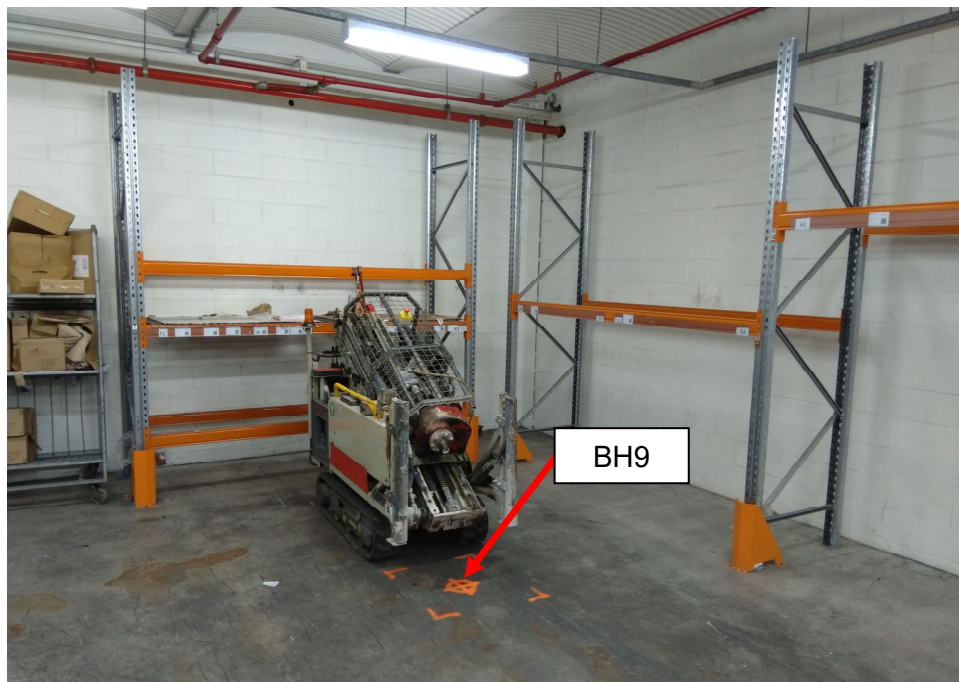
Photo 16 – View to the north-west within the rail catering facility, with the location of Borehole BH9 indicated as shown. The wall at the rear of the view separates the catering facility from an access corridor.

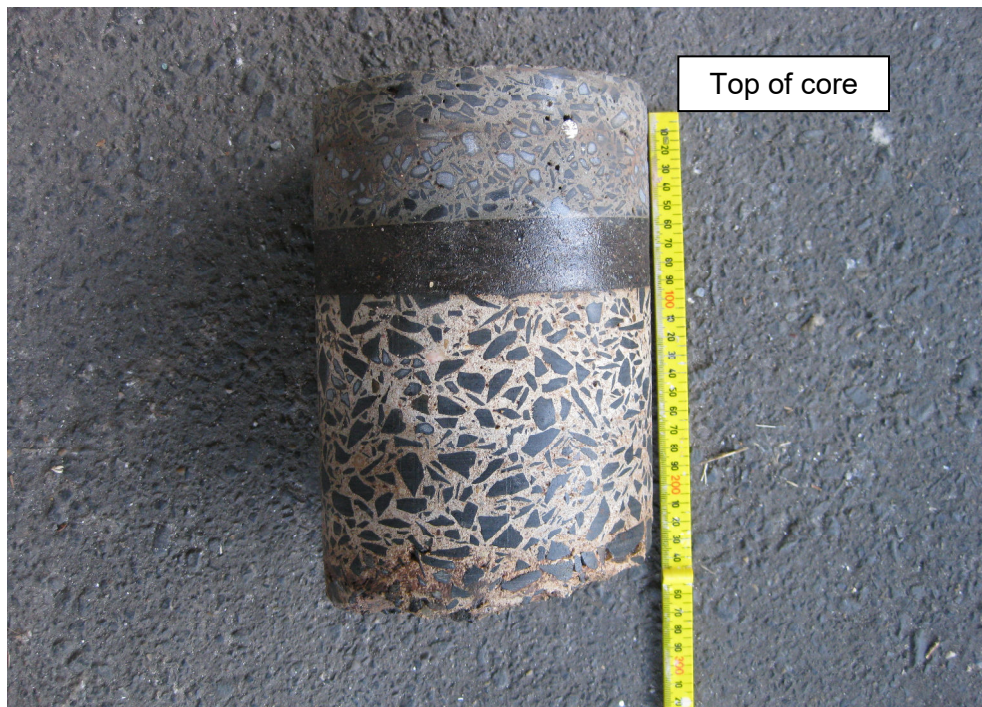
Photo D1 – View of concrete core from Borehole BH6, showing two separate concrete slabs separated by a 30 mm thick asphalt layer. Reinforcement steel (8 mm diameter) was encountered in the lower concrete slab.

The subsurface conditions encountered in the boreholes are presented on the attached borehole logs in Appendix D, along with standard notes defining the descriptive terms and the classification methods used. Photographs of the rock core and selected photographs of the concrete cores are included together with the borehole logs.
