# 113 - 127 Aldington Road, Kemps Creek - Riparian Constraints Assessment

<b>Project Name</b>	113 - 127 Aldington Road, Kemps Creek - Riparian Constraints Assessment
<b>Project Number</b>	19SYD - 14968
<b>Project Manager</b>	Rebecca Ben-Haim
<b>Prepared by</b>	Claire Wheeler
<b>Reviewed by</b>	David Bonjer
<b>Approved by</b>	David Bonjer
<b>Status</b>	Final
<b>Version Number</b>	1
<b>Last saved on</b>	16 December 2019

Eco Logical Australia (ELA) was engaged by Ana Orlovic to provide an assessment of the riparian land and waterway values at 113-127 Aldington Road, Kemps Creek (Lot 36 DP258949) (the study area) (Figure 1). The purpose of this assessment is to compare these values to the riparian land values and proposed zoning in the Western Sydney Employment Area Mamre Road Precinct Rezoning Exhibition Discussion Paper.

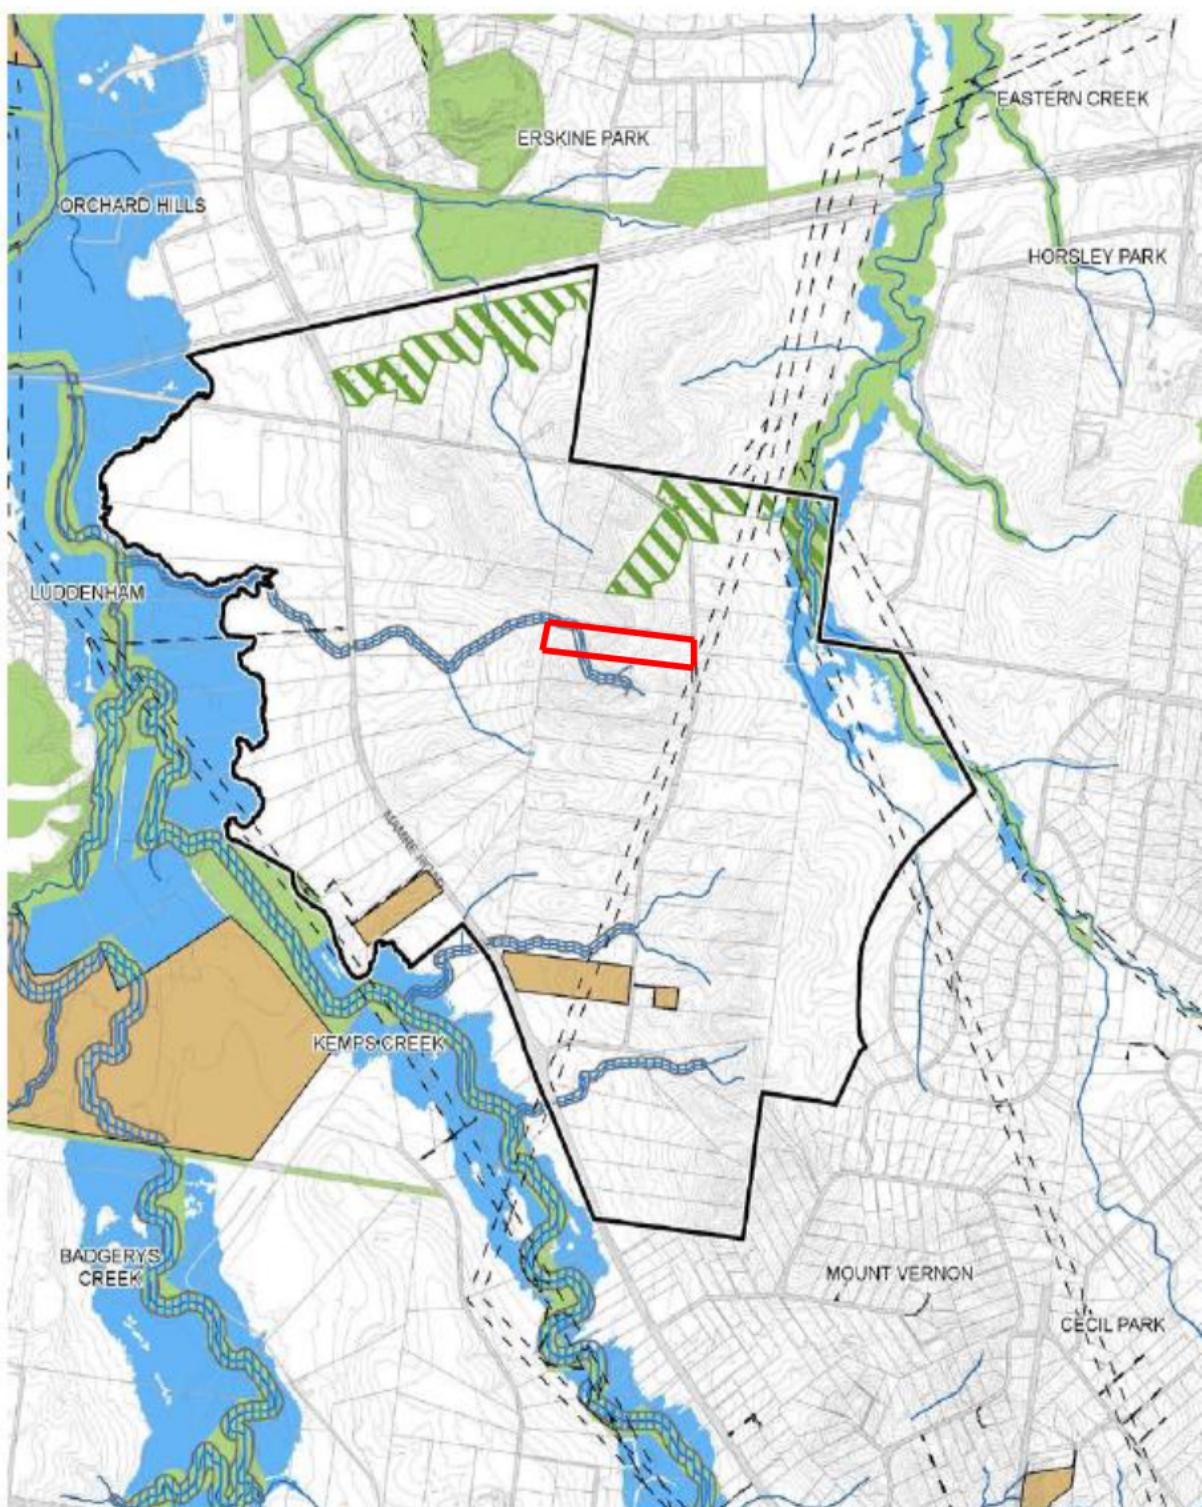
Figure 2: Mamre Road Precinct environmental considerations map (DPIE, 2019). Red indicates study area

The Discussion Paper outlines the existing conditions within the Mamre Road Precinct, including existing areas of riparian land and high biodiversity value (Figure 2). This figure, as well as the Structure Plan (Figure 3), both map the study area as a potential riparian corridor. This assessment was therefore undertaken to determine if the mapped watercourse within the study area met the definition of a 'river' in accordance with the *Water Management Act 2000* (WM Act).

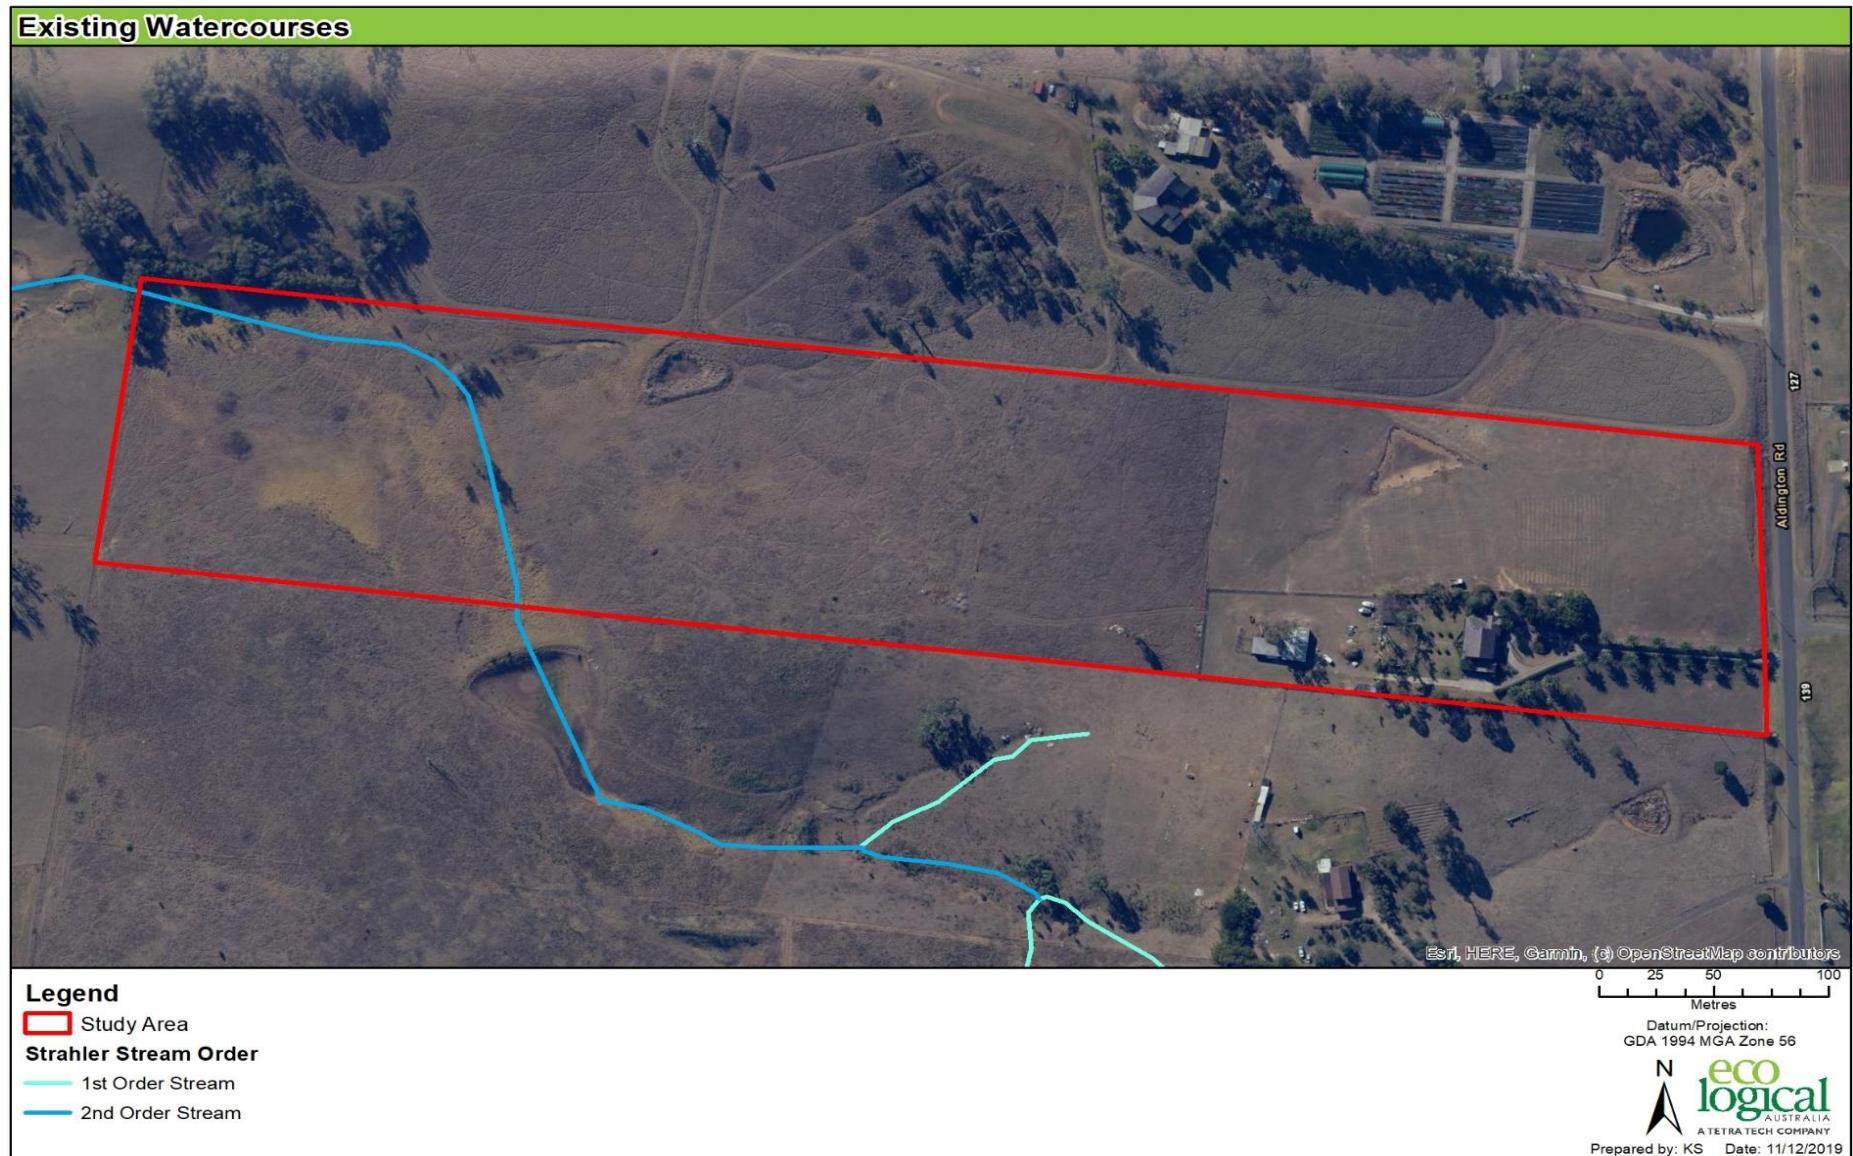
Figure 4: DPI mapped Strahler line within study area

DPI mapping showed one unnamed watercourse within the study area (Figure 4), a 2<sup>nd</sup> order watercourse in the west of the site. This watercourse is a tributary of South Creek / Wianamatta, within the Hawkesbury Nepean catchment.

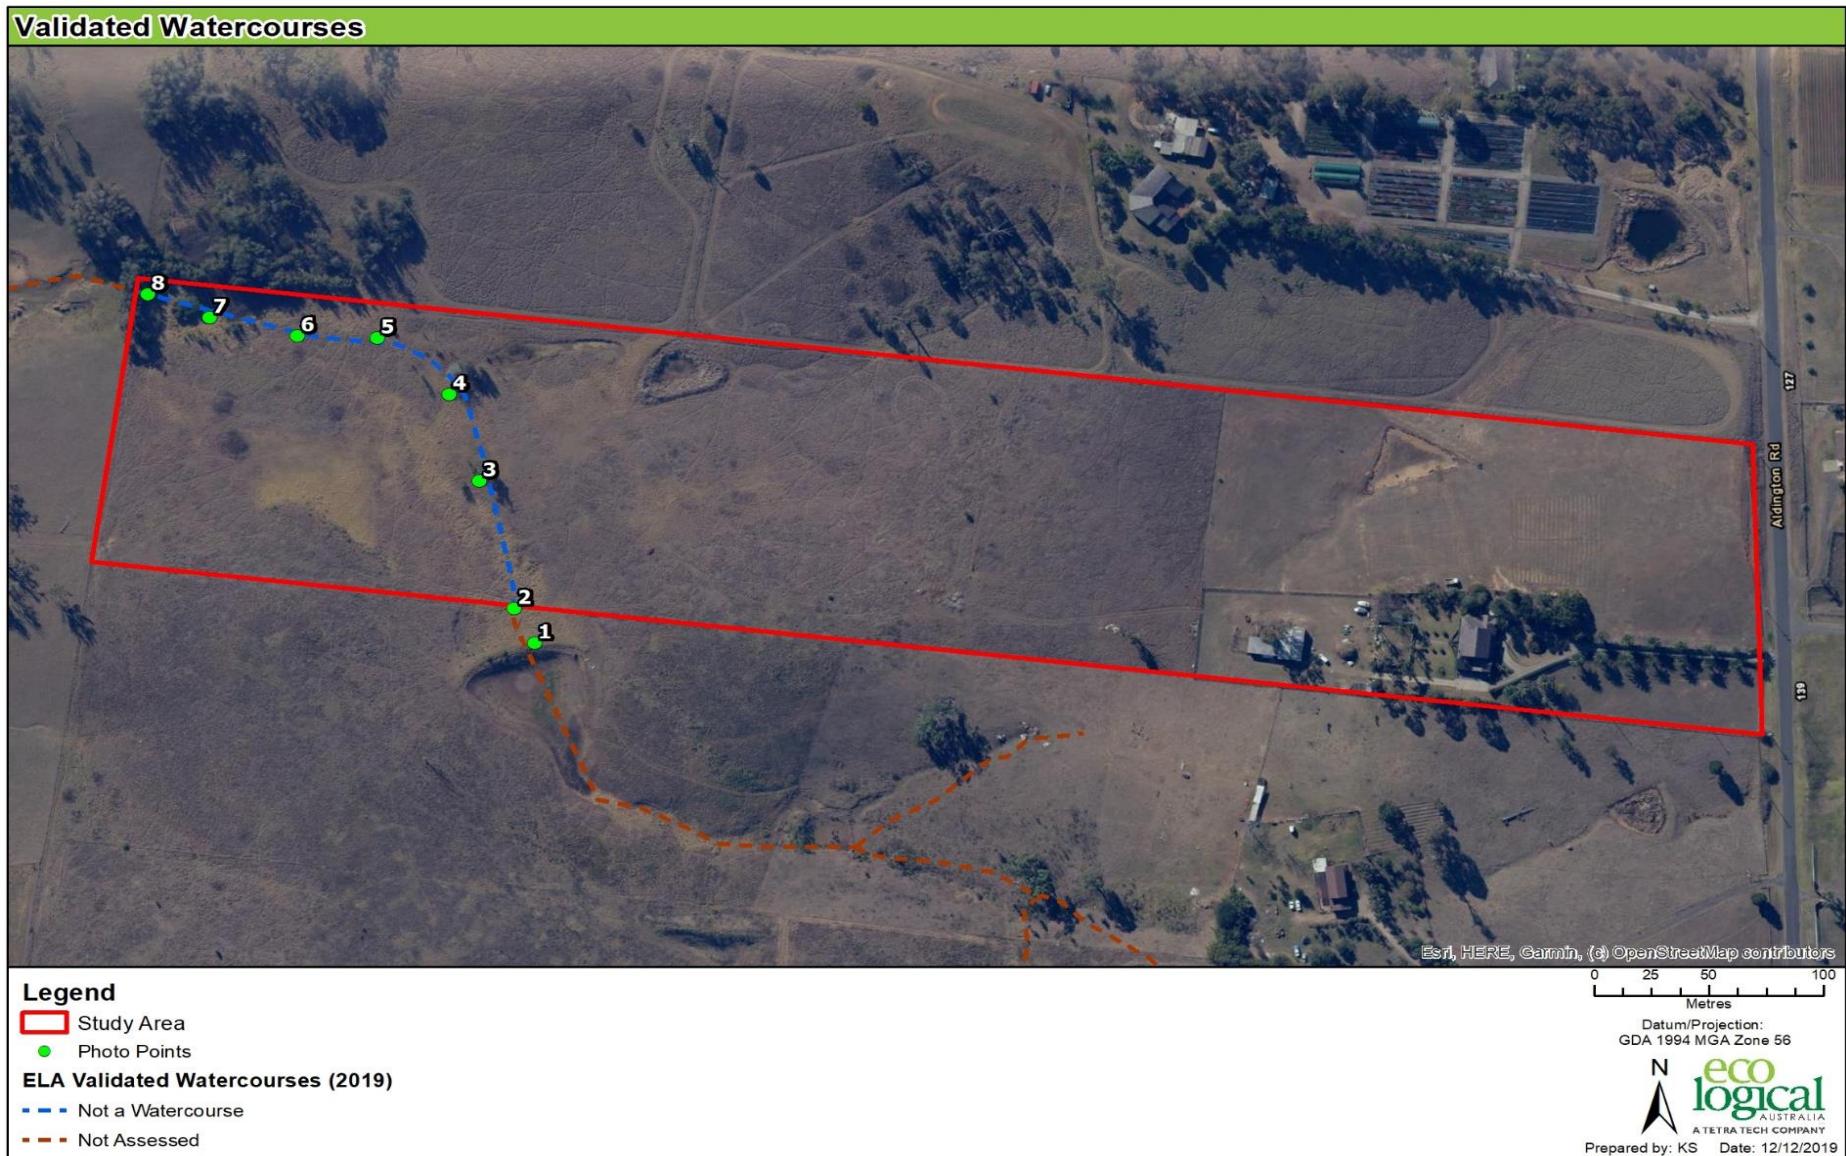
Figure 5: ELA validated watercourses and location of photo points

A map of the validated watercourse within the study area is located in Figure 7. This map also shows the location of photo points along the location of the mapped watercourse. As described below, there is no watercourse channel within the property, although there are likely to be channels both upstream and downstream.

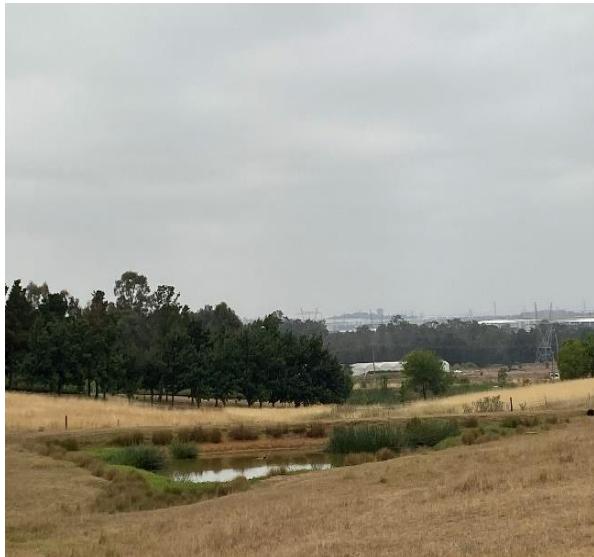
**Figure 6:** Dam in eastern section of study area, looking north.

Two farm dams were located within the study area. The dam within the eastern portion of the property (Figure 6) was located within a grass paddock in a shallow gully. Small pockets of fringing vegetation surrounded the dam, including *Juncus* sp. Eroded, bare banks were observed on the northern side of the dam and a few ducks were seen inhabiting the vegetation near the dam. It is considered that aquatic habitat within this dam is good due to the presence of emergent macrophytes such as *Juncus* sp. This dam was not located on any mapped watercourse.

The removal of the dams within the study area may be subject to conditions of consent from Penrith Council, such as the preparation of a dam de-watering plan, to ensure impacts to downstream environments are minimised. Consultation with Penrith Council would be recommended in order to determine what conditions would need to be satisfied prior to the decommissioning or modification of this dam.

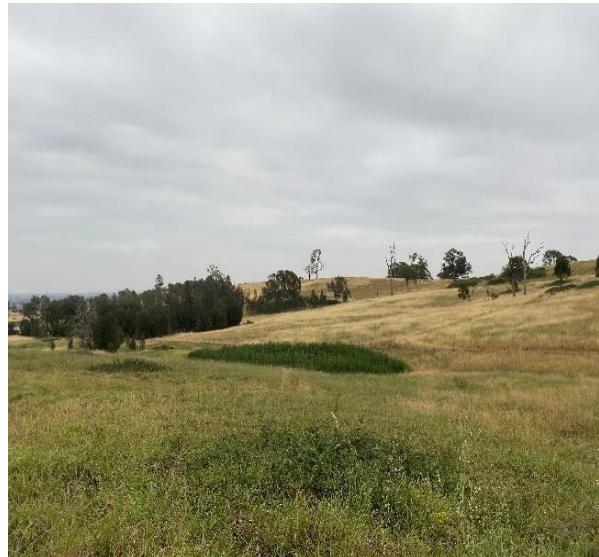
**Figure 7:** Dam in north western section of study area, looking north west.

The dam within the north eastern area of the site (Figure 7) was densely surrounded by *Typha orientalis* (Broadleaf Cumbungi) situated amongst predominantly exotic pasture grasses. Similar to the dam in the eastern area of the site, this dam was not located on a mapped watercourse.

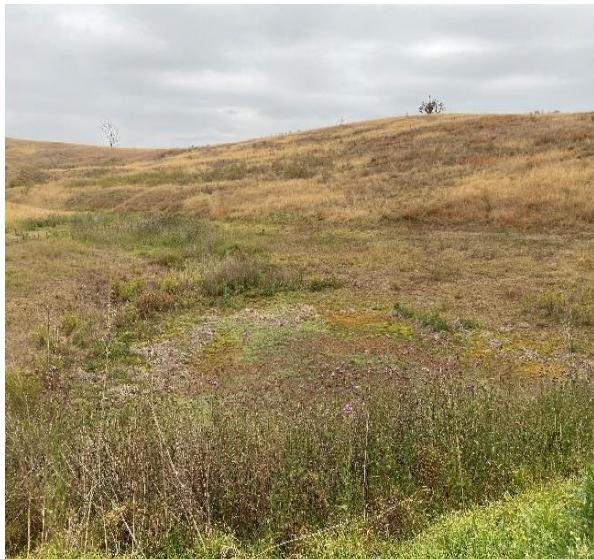
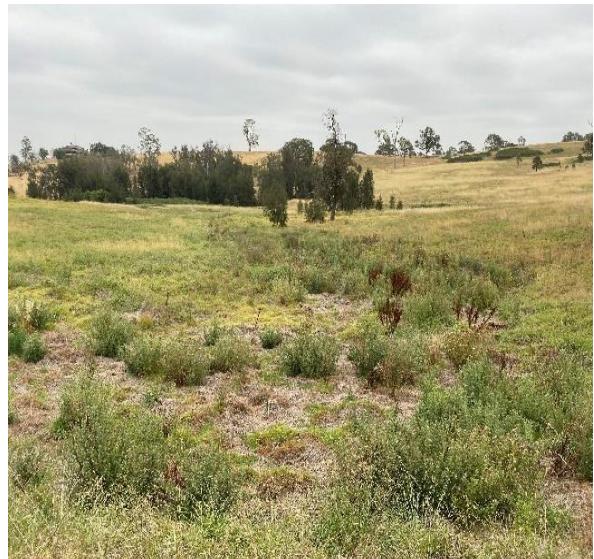
Upstream of where the mapped watercourse was located within the study area, a dry dam was observed near the northern boundary of Lot 35 DP258949 (Figure 8). The outline of the dam could be seen but it appeared that it had not held water for some time. Figure 9 shows the view looking in a downstream direction at Photo Point 1, where there is no defined channel.

Figure 8: Photo point 1, looking upstream.

Figure 9: Photo point 1, looking downstream.

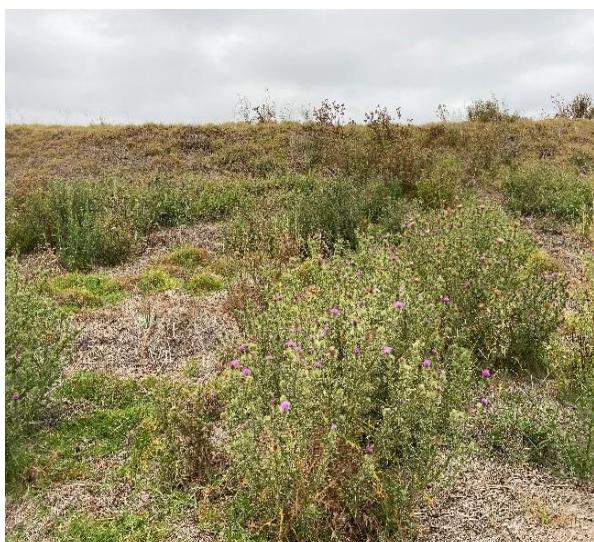
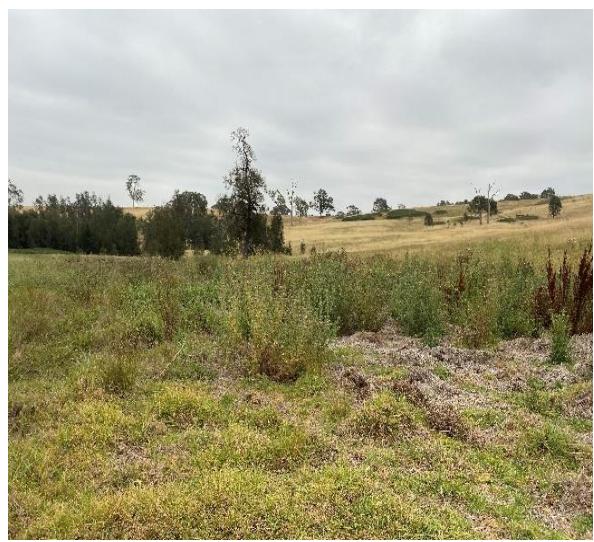
Photo point 2 is located on the southern boundary of the study area, where the mapped second order watercourse enters the property. As shown in Figure 10 and Figure 11, there was no defined channel at this location. Although there was no defined spill way on the downstream side of the dam, it is possible that water flows over this preferential flow path during periods of heavy rain. Vegetation within this area was predominantly exotic, with species including *Lactuca serriola* (Prickly Lettuce) and *Cirsium vulgare* (Spear Thistle) growing in this location, as well as a few sparse native *Juncus usitatus* (Common Rush) plants.

Figure 10: Photo point 2, looking upstream.

Figure 11: Photo point 2, looking downstream.

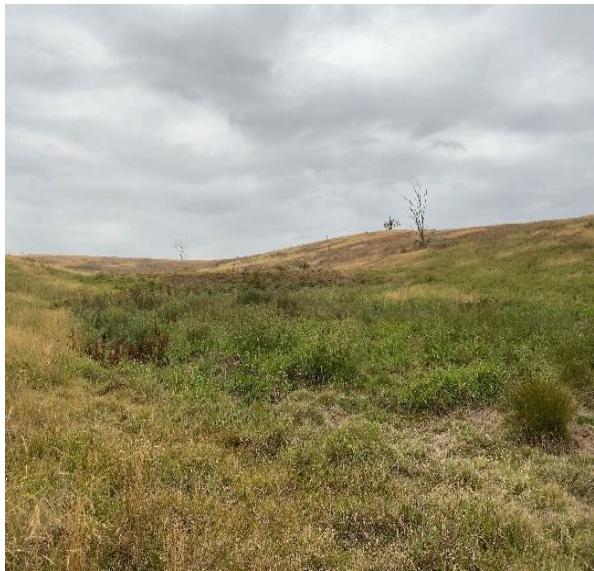
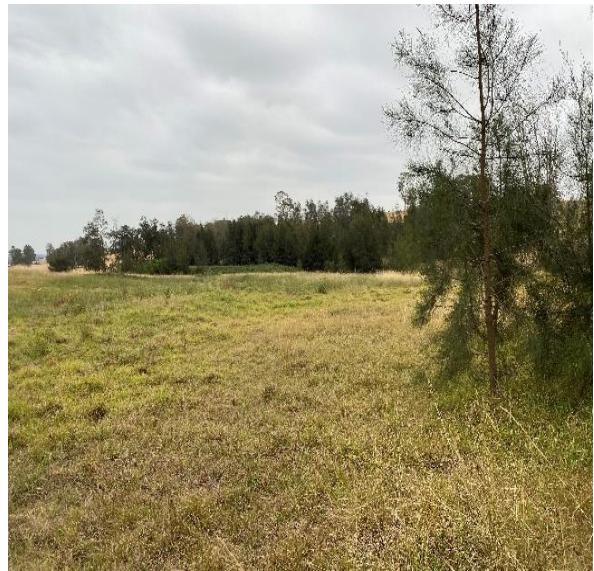
No defined channel was observed at Photo point 3 (Figure 12 and Figure 13), where the area was covered in dense exotic pasture grasses and a few *Casuarina* sp. saplings. To the north of this area, at Photo point 4, where the mapped watercourse was located, was an area covered in dense *Stenotaphrum secundatum* (Buffalo Grass) and no defined channel was observed at this location (Figure 14 and Figure 15).

Figure 12: Photo point 3, looking upstream.

Figure 13: Photo point 3, looking downstream.

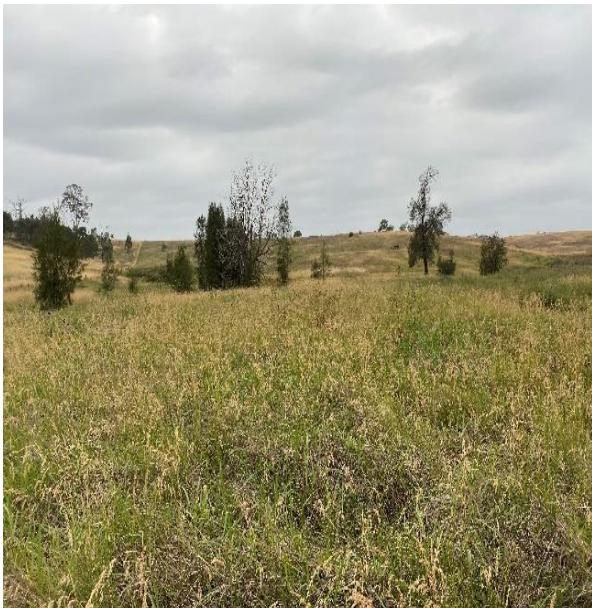
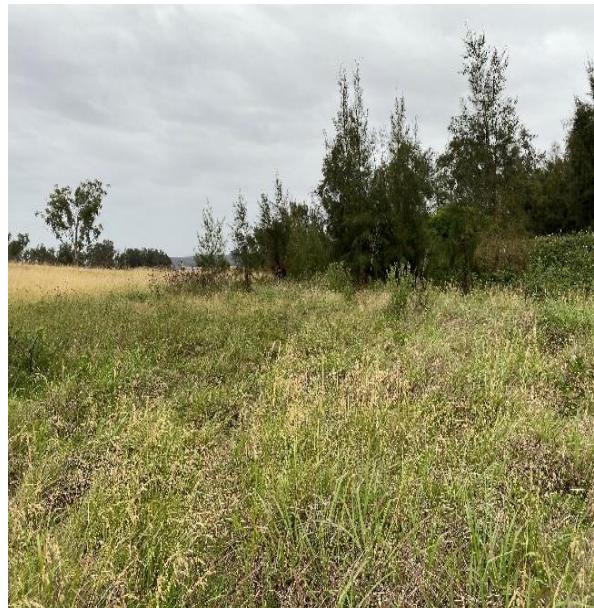
Towards the northern boundary of the study area, Photo point 5 was located on the mapped watercourse. As seen in Figure 16 and Figure 17, no defined channel was observed within this area. There was no shrub layer and very limited, scattered canopy trees. Where the mapped watercourse was located at Photo point 6, the condition of the land was very similar to Photo point 5, with dense *Stenotaphrum secundatum* dominating the ground layer and no bed or banks visible (Figure 18 and Figure 19).

Figure 18: Photo point 6, looking upstream.

Figure 19: Photo point 6, looking downstream.

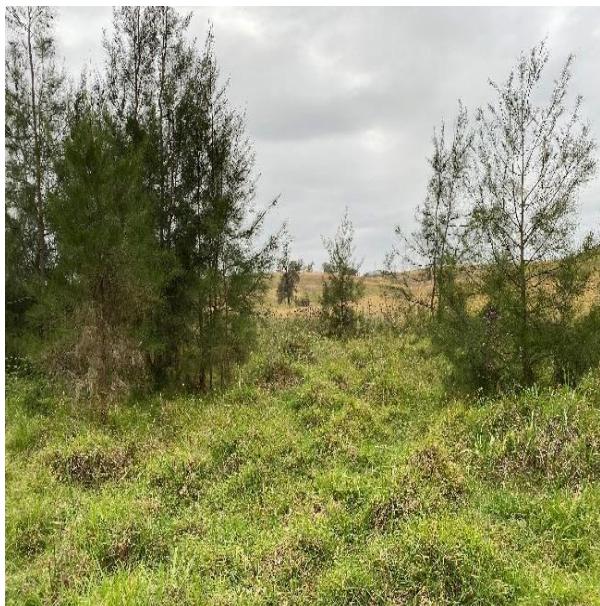
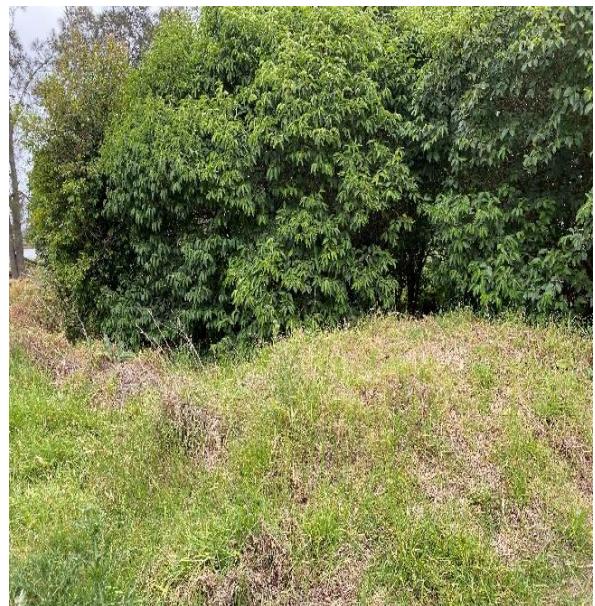
A large dense patch of *Rubus fruticosus* agg. (Blackberry) was located near Photo point 7 and extended into the neighbouring property to the north. No defined bed or banks were observed within the location of the mapped watercourse in this area (Figure 20 and Figure 21) and there was a small stand of *Ligustrum lucidum* (Broad leaf Privet) adjacent to the *Rubus fruticosus* patch.

Figure 20: Photo point 7, looking upstream.

Figure 21: Photo point 7, looking downstream.

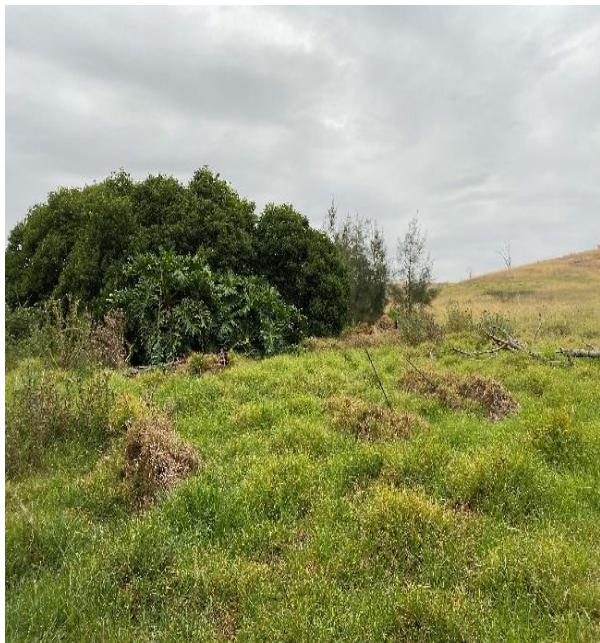
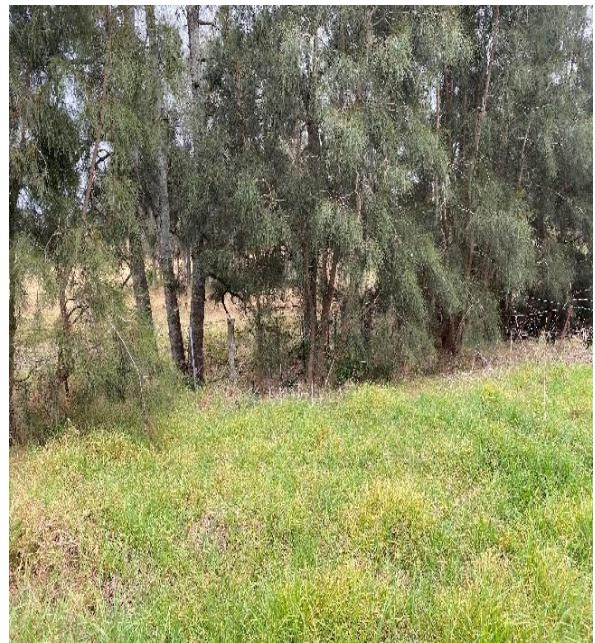
At the location of the mapped watercourse in the north eastern end of the property, there was no defined channel (Photo point 8; Figure 22 and Figure 23). A stand of *Casuarina* sp. was located adjacent to the fenceline on the western and northern boundaries of the property. Dense exotic pasture grasses dominated the ground layer. In the neighbouring property to the north, Lot 37 DP258949, there was a channel that could be seen leading into the dam on Lot 59, DP259135. This channel was approximately 15 m wide and the highest bank was located approximately 5 m from the boundary of the study area.

Figure 22: Photo point 8, looking upstream.

Figure 23: Photo point 8, looking downstream.

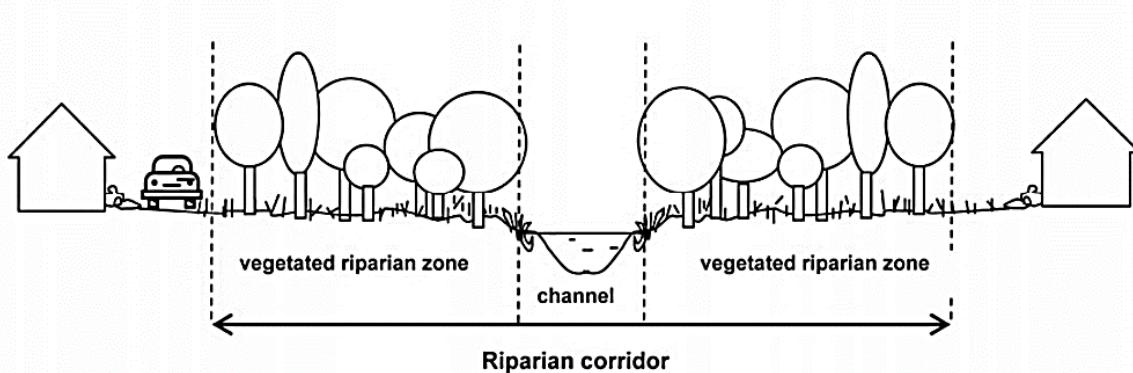
The guidelines outline the need for a Vegetated Riparian Zone (VRZ) adjacent to the channel to provide a transition zone between the terrestrial environment and watercourse. This vegetated zone helps maintain and improve the ecological functions of a watercourse whilst providing habitat for terrestrial flora and fauna. The VRZ plus the channel (bed and banks of the watercourse to the highest bank) constitute the 'riparian corridor' (Figure 24). NRAR recommends a VRZ width based on watercourse order as classified under the Strahler System of ordering watercourses and using Hydroline Spatial Data which is published on the department's website (Table 3).

Figure 24: Vegetated Riparian Zone and watercourse channel comprising the riparian corridor (NRAR, 2018).

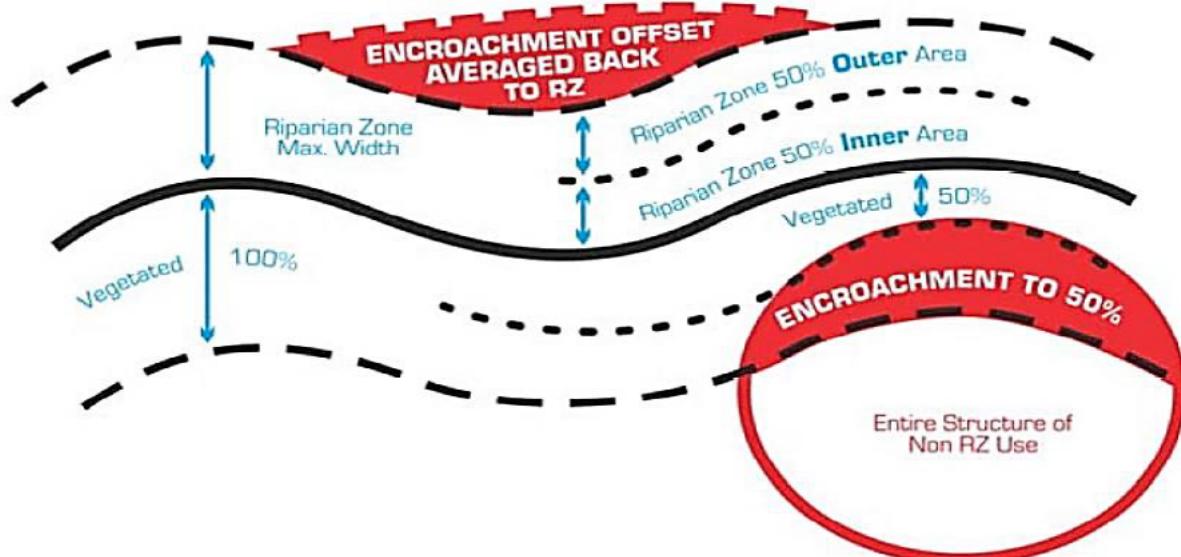
Non-riparian uses can be authorised by NRAR within the outer 50% of the VRZ (Table 4), as long compensation (1:1 offset) is achieved within the site. The outer VRZ that is impacted must be offset elsewhere on site using the 'averaging rule' (Figure 25).

**Figure 25: Riparian 'averaging rule' for offsetting encroachment into the outer 50% of the VRZ (NRAR 2018).**
