SUBMISSION: DRAFT CUMBERLAND PLAIN CONSERVATION PLAN

PROPOSED E2 BOUNDARY / ZONING – [REDACTED] BRINGELLY, NSW, 2556

Re: Draft Cumberland Plain Conservation Plan
Riparian Assessment at ██████████ Bringelly

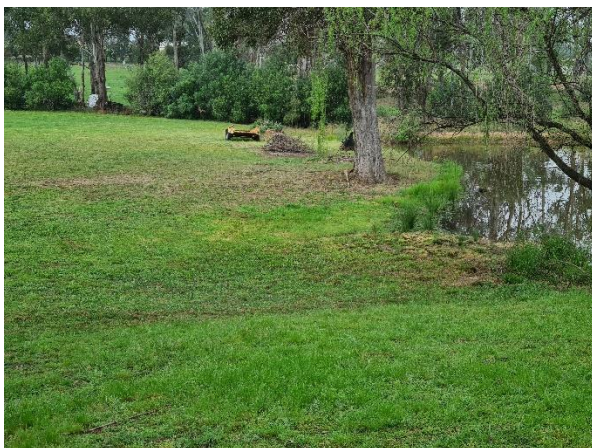
The mapped waterway is between the two dams, and includes the dam on No. [REDACTED] I observed a grass-vegetated swale that connects the two farm dams (Figures 4 and 5). Other than the depression that was the basis of the swale, there was no evidence of stream processes observed.

Figure 4: Inflow to dam at [REDACTED]

I conclude that the mapped 2nd Order Strahler waterway at [REDACTED] has no evidence of active stream processes. In my opinion, the mapped waterway could be extinguished and removed from the proposed zoning with no loss of waterway values.

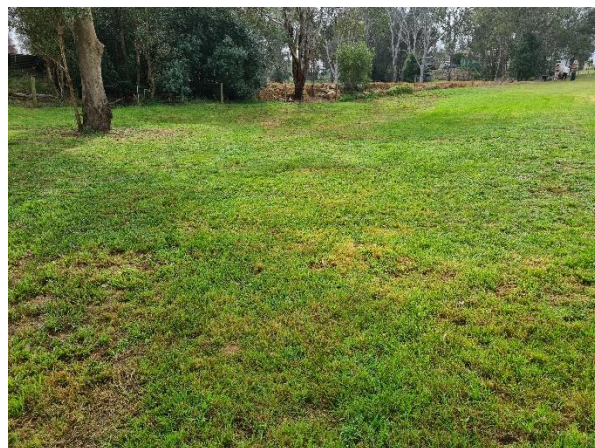
Figure 5: [REDACTED] looking uphill in the swale to [REDACTED]
